UNITED STATES  
NUCLEAR REGULATORY COMMISSION  
OFFICE OF INSPECTION AND ENFORCEMENT  
WASHINGTON, D.C. 20555

IE Information Notice No. 80-38: CRACKING IN CHARGING PUMP CASING CLADDING

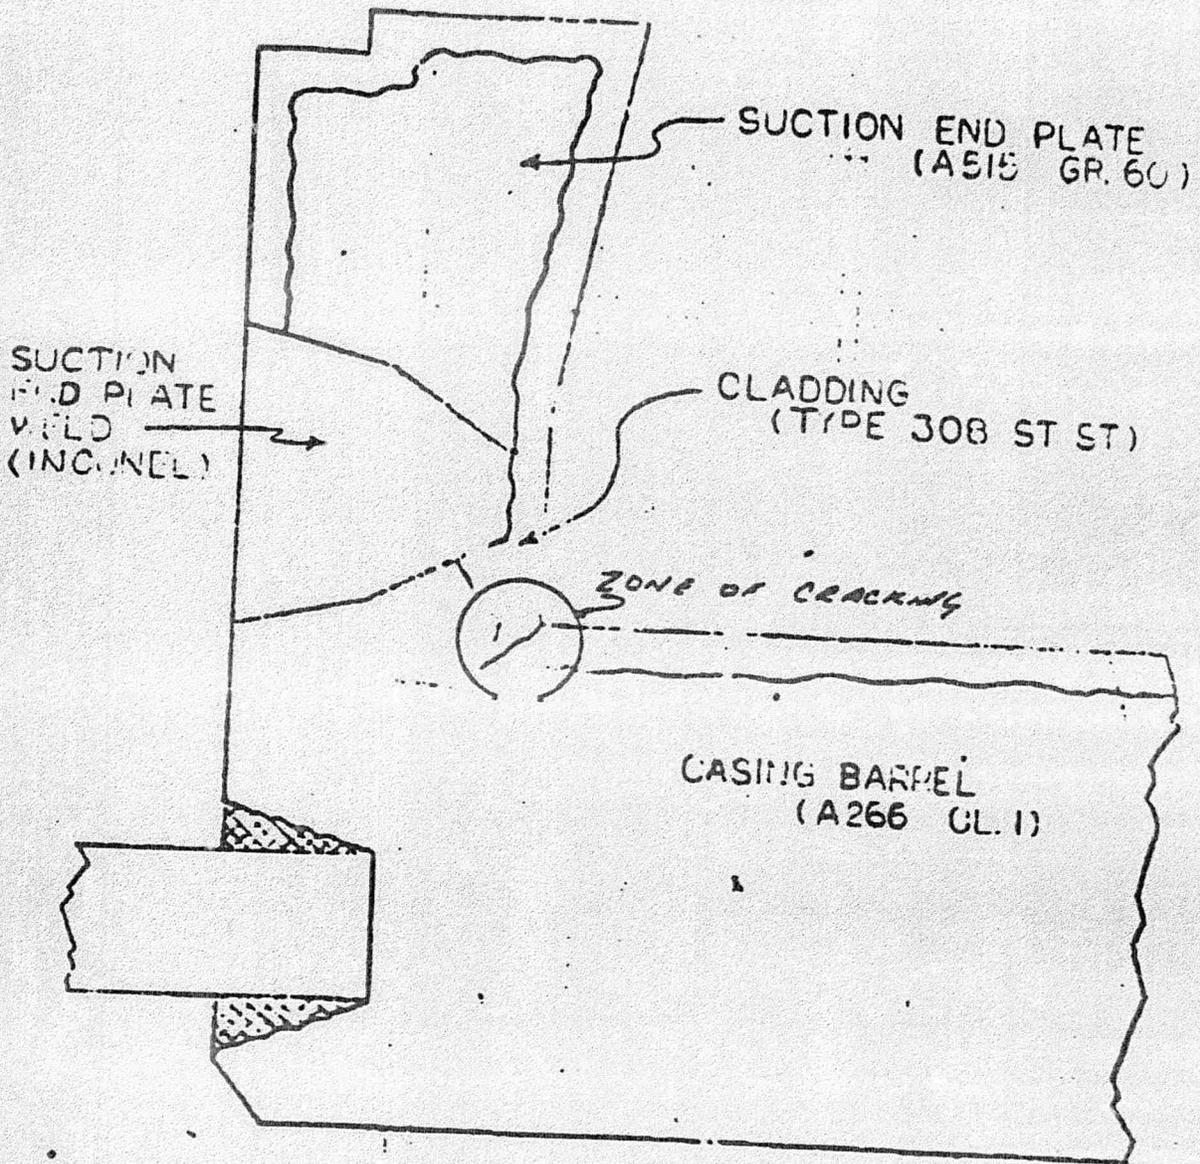
FIGURE 1

The pumps are 2-1/2 inch, 11 stage, Type IJ manufactured by the Pacific Pumps Division of Dresser Industries. The pump casing end assembly in the area of interest, Figure 1, consists of a suction end plate of A515 grade 60 carbon steel plate welded to the casing barrel forging of A266 class 1 carbon steel using an Inconel weldment. The entire inner surface is clad with type 308 stainless steel applied by submerged arc welding.

An in-situ ultrasonic examination conducted in late April confirmed clad cracking indications at the barrel case to end plate inner radius for approximately 330 degrees around the circumference and that the cracking possibly extended into the pump base material in the bottom 180 degrees of the assembly. A review of the original radiographs revealed crack like indications in the clad overlay, however, not to the extent observed during this examination.

Subsequently, the entire suction end of the pump was removed and cross sections metallographically examined to further evaluate the nature and extent of the cracking. It was determined that initiation and propagation of the clad cracks probably resulted from stress concentration and dilution effects in the initial corner bead pass due to the difficult access and bead sequencing required by the fairly sharp corner geometry. Extension of the cracks at the base metal-clad interface ranged to a depth of 1/16 inch maximum in the 1-1/2 inch thick base material. These crack tip areas were well blunted and slightly cavitated from corrosion effects due lengthy exposure to the localized boric acid attack. Examination of the crack morphology revealed that the clad cracking essentially arrested at the base metal-clad interface and that base metal corrosion progressed at a relatively slow rate.

The 1A charging pump was replaced with a new pump provided with a casing constructed entirely of stainless steel. The licensee is currently developing improved NDE procedures for examination of the three remaining pumps at the next refueling outage. Further, the licensee and pump manufacturer are developing repair procedures in the event cracks are discovered in the remaining pumps.

Based on the available information no immediate safety concern is indicated. However, the observed conditions reveal a potential source of pump degradation over long term operations. Therefore, to assure maximum availability, it appears prudent to perform a nondestructive examination of this pump type at the earliest practical time during the first code required in-service inspection interval and if cracking is confirmed, take appropriate corrective actions per the rules of ASME Section XI BP&V Code.
