Development of a Ready-to-Assemble Tornado Shelter from Cross-Laminated Timber (CLT)

Impact and Wind Pressure Testing

General Technical Report
FPL-GTR-266

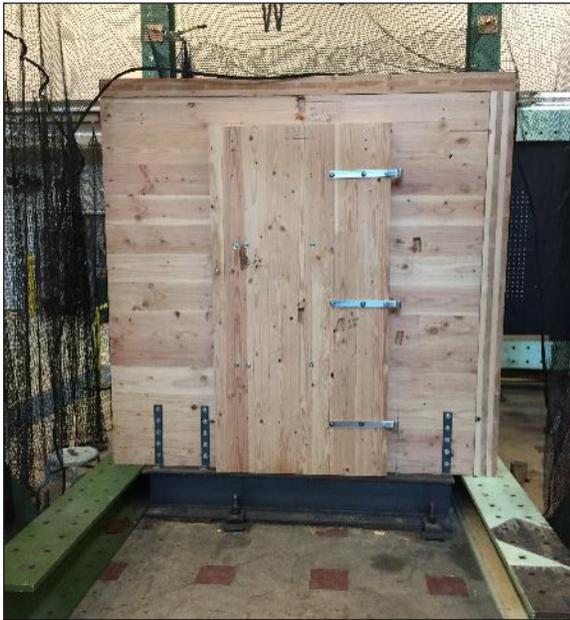
Figure 1—8- by 8-ft CLT tornado shelter.

Two sizes of tornado shelters constructed from each thickness of panel were evaluated. The first was a shelter 8 by 8 ft in plan (exterior dimensions) with a height of 8 ft (Fig. 1). This larger shelter, similar in size to that described in Falk and Bridwell (2018) is large enough for other uses (such as bathroom, utility shelter, sauna) when not needed in an emergency. The second shelter evaluated was 5.5 by 5.5 ft in plan (exterior dimensions) with a height of 7.67 ft (Fig. 2). Per FEMA recommendations of 5 ft² per person, the larger shelter will accommodate nine people and the smaller shelter five people.

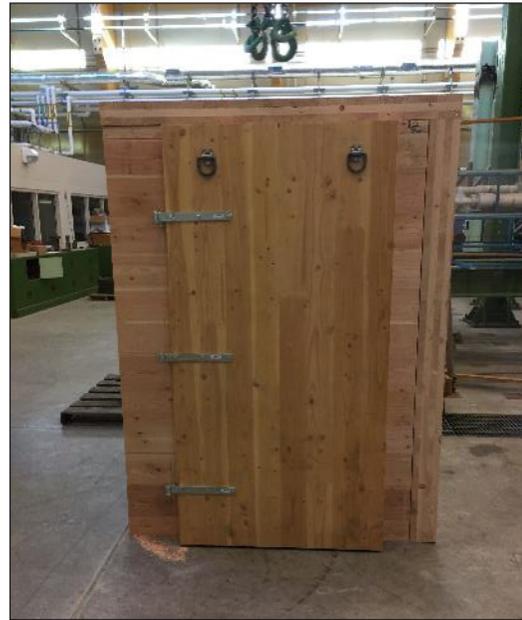
Figure 2—5- by 5-ft CLT tornado shelter.

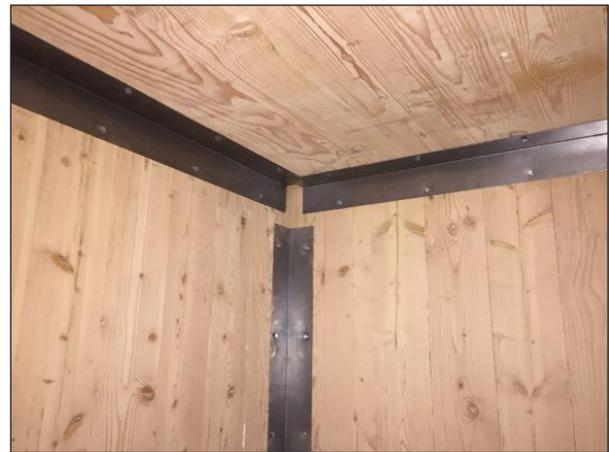
Figure 3—Sheet steel angles for connecting CLT panels.

The CLT panels were provided prefabricated and cut to size. Once at the Forest Products Laboratory (FPL), the panels were connected together with custom-made 14 gauge sheet steel angles. These 4- by 4-in. angles were attached at each inside shelter corner with 3/8- by 3-in. lag bolts (predrilled, 8 in. on center (o.c)). This panel connector system allowed the butting of CLT panels without field modification (Fig. 3). This connection system allowed for rapid construction. Each shelter was assembled by two people using only an overhead crane and hand tools in less than 4 hours.

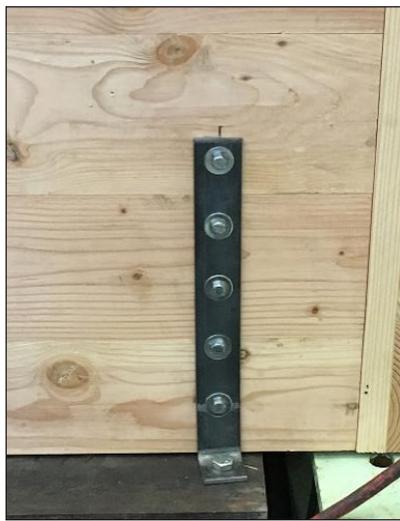
Figure 5—Shelter hold-down.

Securing the tornado shelter to the foundation is another important aspect of tornado shelter design. The hold-down connector, the anchors securing the hold-down connector, and the concrete foundation each must have adequate structural strength to resist the wind forces produced by a tornado. The hold-down connector utilized in the CLT safe shelters described here is a simple 13-in. long, 2-in. wide, 1/4-in. thick A36 steel bar bent in an “L” shape to allow attachment to a concrete floor (Fig. 5).

Each hold-down is attached to the tornado shelter using five 3/8- by 3-in. long lag bolts, and each hold-down has a 3/4-in.-diameter through hole on the shorter leg for anchoring to the foundation. For the 8- by 8-ft shelter, 12 hold-downs were used, three on each wall. One hold-down was placed approximately at the center of each wall

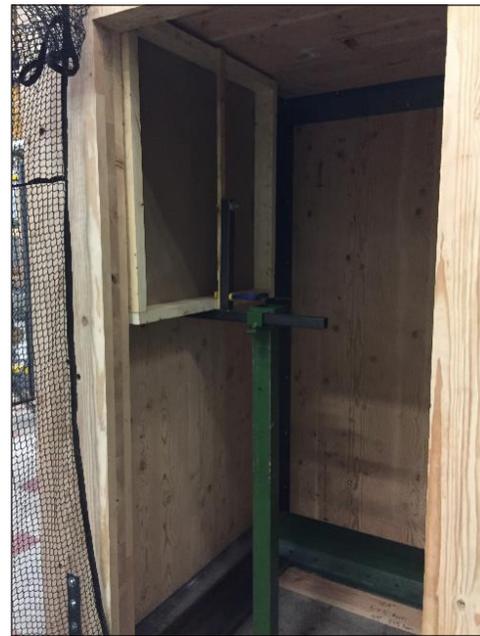
Figure 6—Witness screen erected inside the shelter.

ICC/NSSA-500 also requires that a paper witness screen of taut 70-lb kraft paper be erected no more than 5 in. behind the interior surface of the wall being tested. Any perforation of the screen by debris or a deforming wall is considered a failed test.

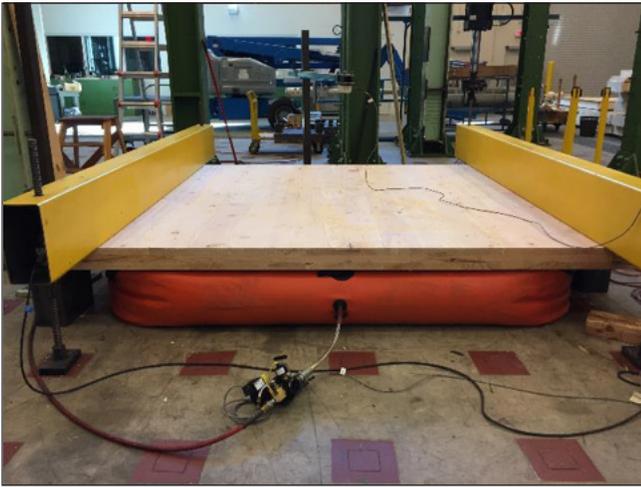
Figure 8—Panel wind pressure test setup.

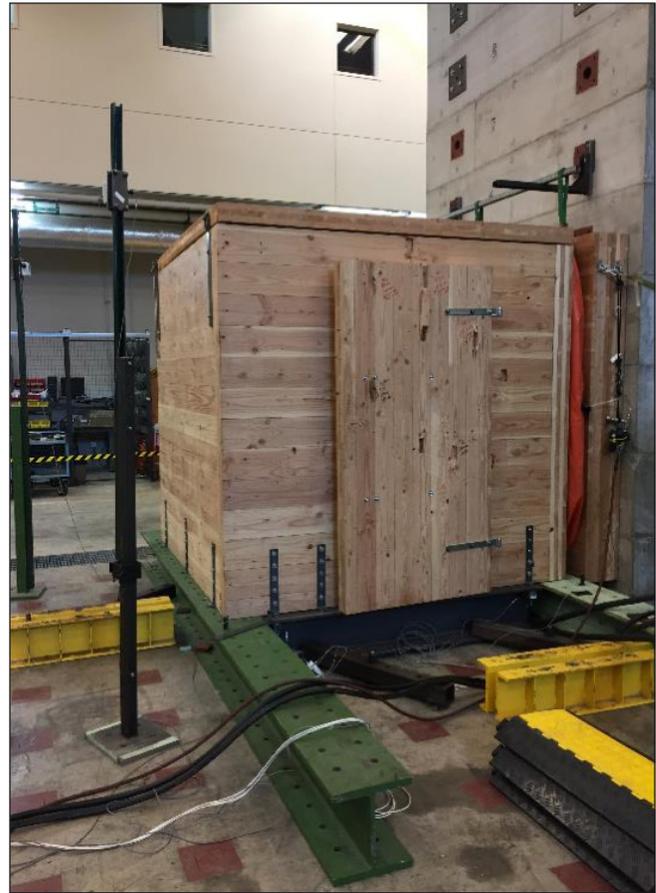
Figure 9—Tornado shelter tied down to strong floor.

Similar to the impact tests, the full-size shelter was secured to the strong floor of the test laboratory through a series of steel beams, which in this case were placed adjacent to a reinforced concrete strong wall (Fig 9). The same airbag described earlier was sandwiched between the tornado shelter and the strong wall to simulate a uniformly applied wind load to the side of the shelter (Fig. 10). The lateral wind pressure load was applied using the same regulator, software, and procedure as outlined for the pressure test on the panel.

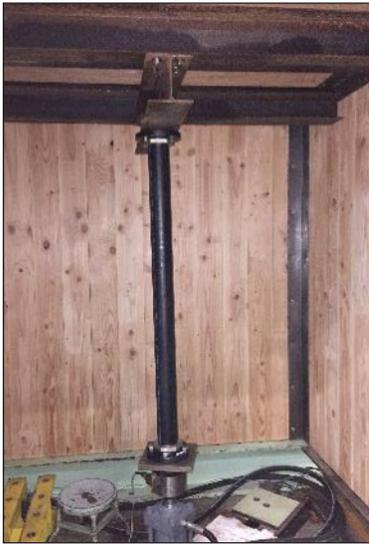
Figure 11—Uplift loading on CLT tornado shelter roof.

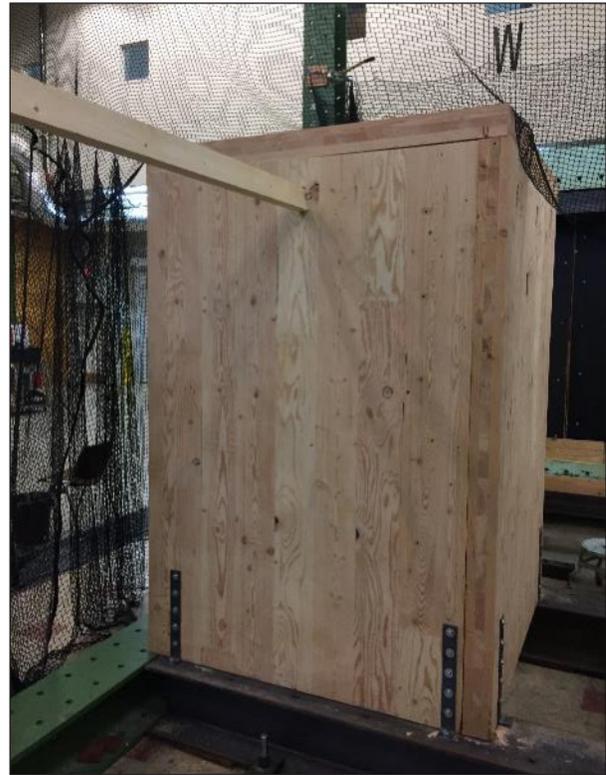
Figure 12—Single impact test to three-ply 5- by 5-ft shelter.

The three-ply panel failure mentioned above suggested that an 8- by 8-ft shelter constructed of three-ply panels would not perform well, but we speculated that a three-ply shelter of smaller size might pass the impact test. Therefore, a 5- by 5-ft (interior dimension) three-ply shelter was built and subjected to impact. Figure 12 shows the results of

the single impact test that was performed on this shelter. As shown in Figures 12 to 14 and Appendix D, the three-ply panel deflected more than 3 in. and debris pierced the witness screen. The shelter therefore failed the test. This test and the three-ply panel test described above suggest that a three-ply panel was too thin to resist the most severe impact forces dictated by the standard.

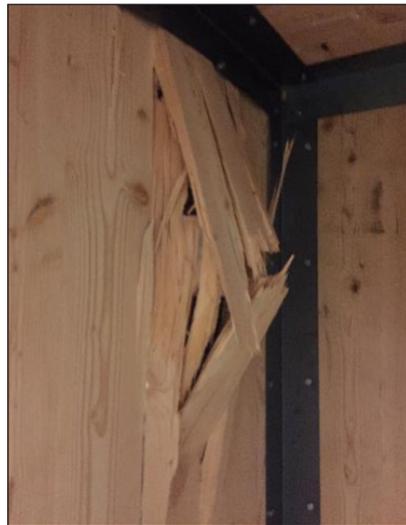
Figure 13—Interior damage to three-ply 5- by 5-ft shelter.

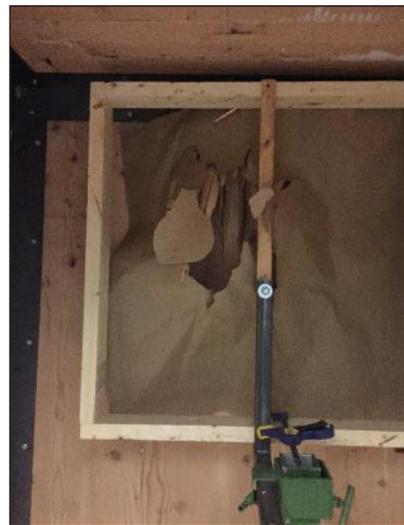
Figure 14—Tearing of witness paper.

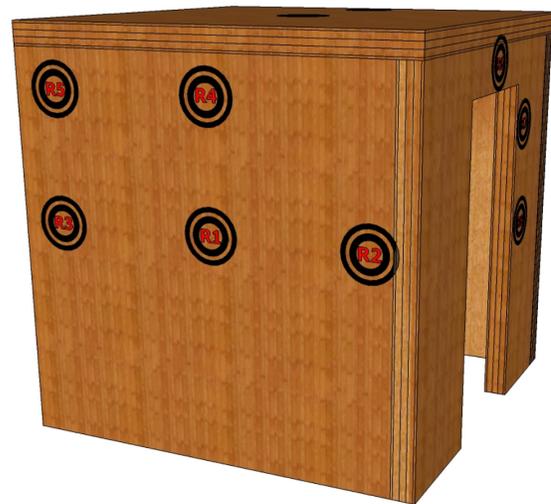
Figure 15—Impact locations on wall panel of four-ply 8- by 8-ft shelter.

Because of the failure of the three-ply panel and the three-ply 5- by 5-ft shelter, an 8- by 8-ft shelter constructed of four-ply CLT was tested. Figures 15 and 16 indicate the locations of impact on the full-size shelter.

Impact tests R1 to R5 were performed in sequence on the same shelter wall. As indicated in Appendix C, impact test R1 was intended to evaluate the resistance of the wall panel by targeting the geometric center of the panel. Tests R2 and R3 were positioned to concentrate forces at the wall–wall interface. Impact tests R4 and R5 were positioned to evaluate the wall–wall–roof and wall–roof interface, respectively. In all cases, the four-ply wall resisted the impacts with little or no damage.

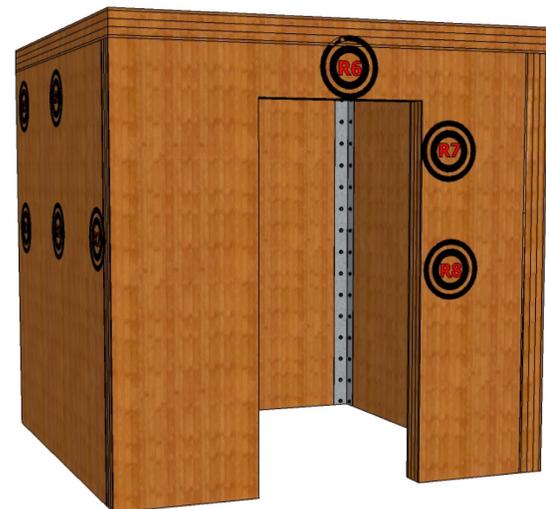
Figure 16—Impact locations on 8- by 8-ft shelter around door. (Door not shown for clarity.)

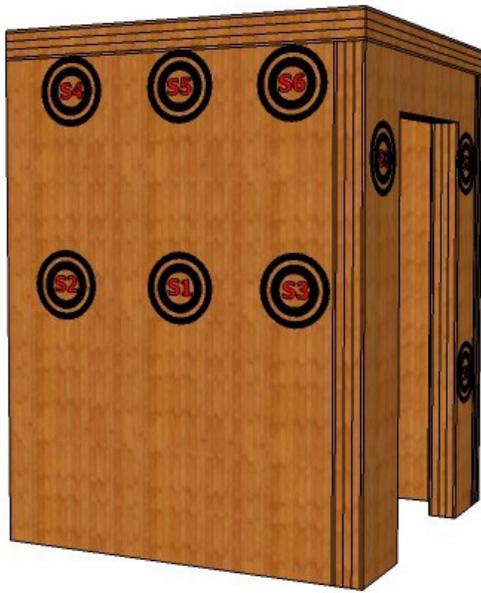
Figure 17—Impact locations on 5- by 5-ft shelter on wall panel.

Wall panel—Impact tests S1 to S6 were performed in sequence on the same shelter wall. As indicated in Figure 17 and Appendix D, impact test S1 was intended to evaluate the resistance of the wall panel by targeting the geometric center of the panel. Tests S2 and S3 were aimed to concentrate forces at the wall–wall interface at the mid-height of the wall panel. Impact tests S4 to S6 were aimed to evaluate the wall–wall–roof and wall–roof interface. In all cases, the four-ply wall resisted the impact with little or no damage and passed the test.

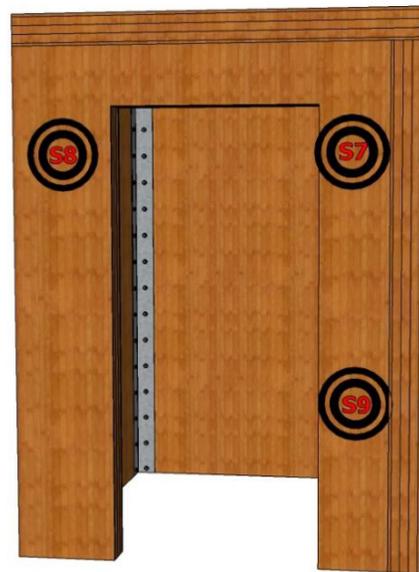
Figure 18—Impact locations on 5- by 5-ft shelter around door. (Door not shown for clarity.)

Door panel—Impact tests S7 to S9 were performed on the wall panel containing the door opening. These tests were directed near the door edge and indicated if the perimeter of the opening could withstand the applied impact forces. As indicated in Figure 18 and Appendix D, three tests were performed. In test S7, the missile was directed adjacent to the door between the door top and the roof panel. Tests S8 and S9 were directed between the upper and lower door hinges, respectively. In all tests, the door panel resisted the impact with no significant damage nor debris and passed the test.

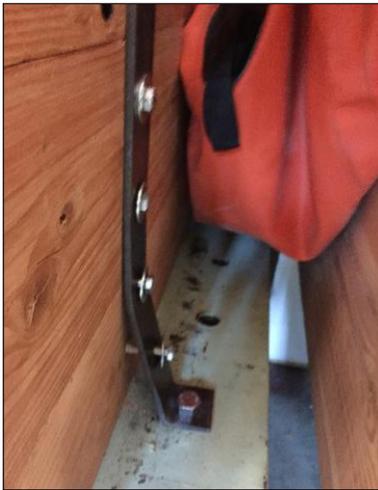
Figure 22—Pullout of lag bolt at 2.3× design wind load.

In both tests, the shelter walls and roof showed no damage or distress at 2.3× design. Some bending of the tie-downs and pullout of a lag bolt from the tie-downs on the load side did occur (Fig 22). The authors feel that this localized distress is not worrisome because significant capacity

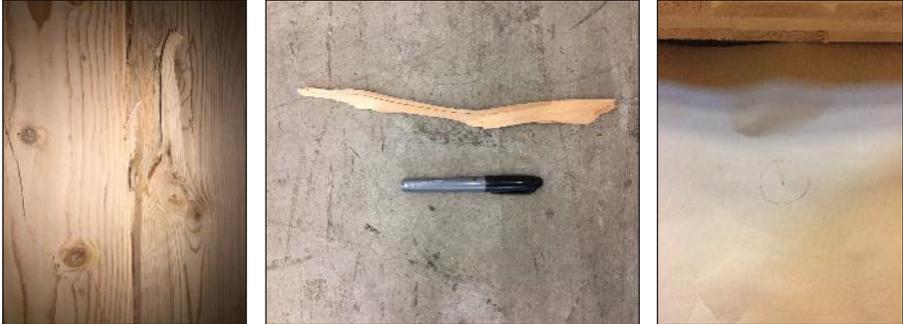
Test no.	Panel construction	Missile speed (mph)	Front penetration (in.)	Permanent deflection (in.)	Panel/door perforated (Y/N)	Observed damage	Passed test (Y/N)	Additional notes
P1	3-ply wall	106.7	1.9	1.6	N	Sliver of debris perforated witness screen	N	Impact at geometric center of panel

<p>Left to right: Back side of panel, sliver of debris, hole in witness screen.</p>

Before building and testing a full-size shelter, an 8- by 8-ft three-ply CLT wall panel was impact tested to determine if a three-ply panel could resist the impact loads. The first test was performed at the geometric center of the panel (P1, App. A). The panel failed the test because a piece of debris punched a small hole in the witness screen.

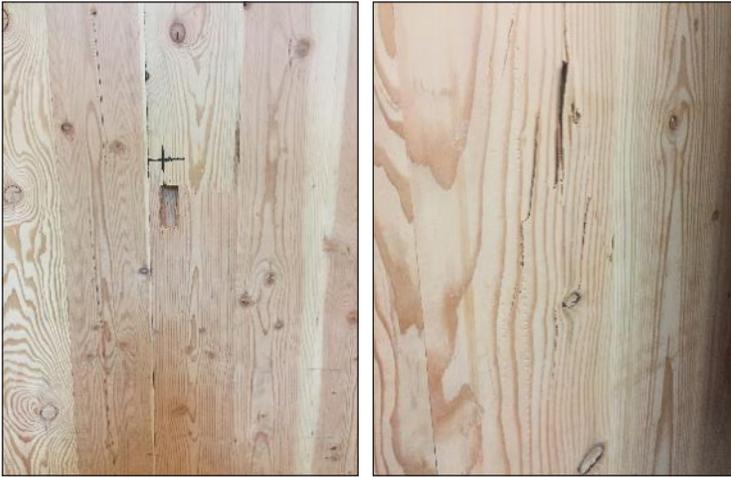
Test no.	Panel construction	Missile speed (mph)	Front penetration (in.)	Permanent deflection (in.)	Panel/door perforated (Y/N)	Observed damage	Passed test (Y/N)	Additional notes
P2	3-ply roof	85.9	1.0	<0.5	N	Slight cracking of back side of panel	Y	Impact at geometric center of roof panel; target speed 67 mph

<p>Left to right: Impact at front of roof panel, slight cracking at back of panel.</p>

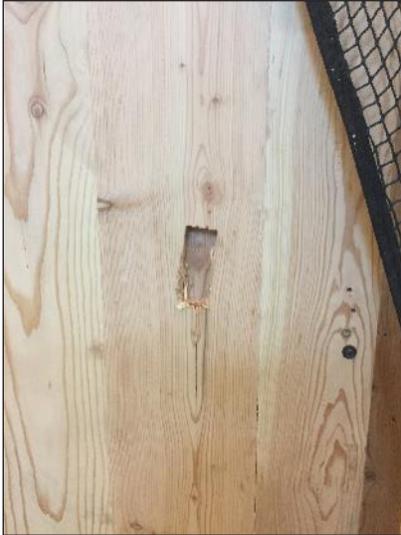
Test no.	Panel construction	Missile speed (mph)	Front penetration (in.)	Permanent deflection (in.)	Panel/door perforated (Y/N)	Observed damage	Passed test (Y/N)	Additional notes
P3	3-ply roof	78.0	1.0	0.5	N	Slight cracking of back side of panel	Y	Impact 6 in. from edge of roof panel; target speed 67 mph

Impact at front of roof panel.

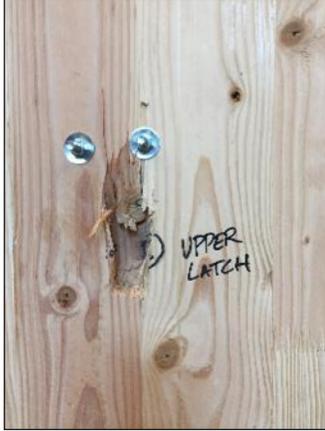
Test no.	Door panel construction	Missile speed (mph)	Front penetration (in.)	Permanent deflection (in.)	Panel/door perforated (Y/N)	Observed damage	Passed test (Y/N)	Additional notes
D1	3-ply	103.4	2.0	<0.5	N	None to back side of door	Y	Shot to upper door latch; latch operable after impact

Front of door penetration.

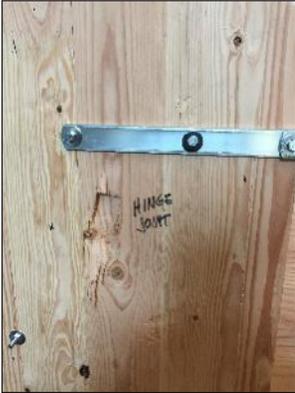
Test no.	Door panel construction	Missile speed (mph)	Front penetration (in.)	Permanent deflection (in.)	Panel/door perforated (Y/N)	Observed damage	Passed test (Y/N)	Additional notes
D2	3-ply	104.4	0.8	<0.5	N	None to back side of door	Y	Shot to hinge; door operable after impact

Front of door penetration.

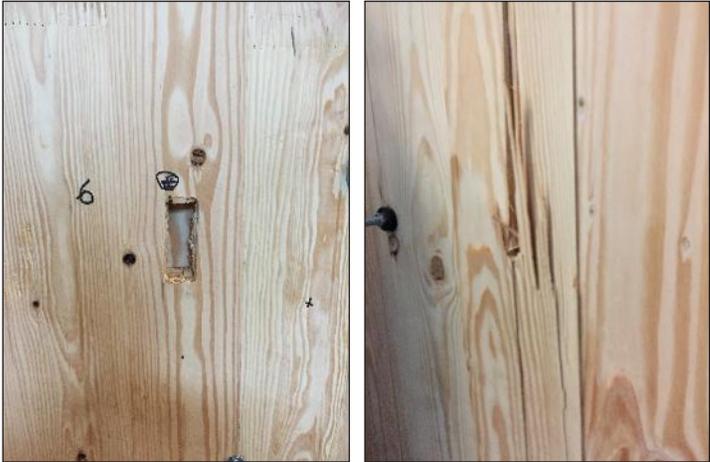
Test no.	Door panel construction	Missile speed (mph)	Front penetration (in.)	Permanent deflection (in.)	Panel/door perforated (Y/N)	Observed damage	Passed test (Y/N)	Additional notes
D3	3-ply	103.2	1.6	<0.5	N	Slight cracking of wood behind impact	Y	Shot to geometric center of door halfway between door latches; door operable after impact

<p>Left to right: Front of door penetration, slight cracking of back of door.</p>

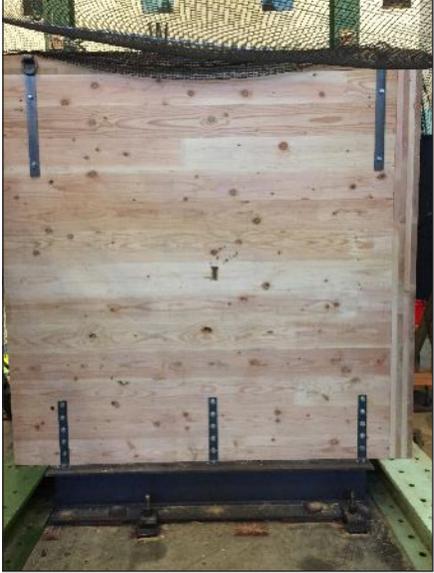
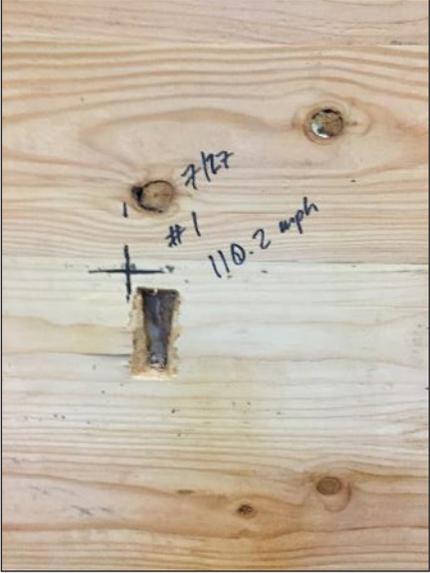
Test no.	Panel construction	Missile speed (mph)	Front penetration (in.)	Permanent deflection (in.)	Panel/door perforated (Y/N)	Observed damage	Passed test (Y/N)	Additional notes
R1	4-ply	110.2	1.8	<0.5	N	NA	Y	Impact at geometric center of panel

Left to right: Front of panel penetration, close-up of panel penetration.

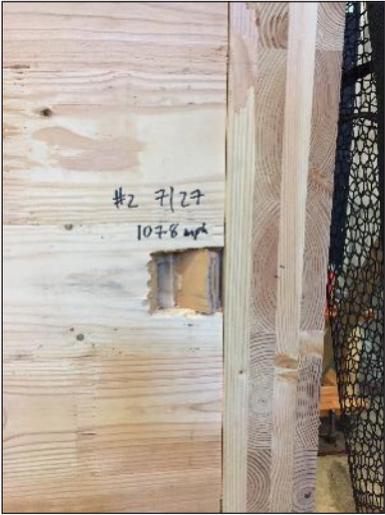
Test no.	Panel construction	Missile speed (mph)	Front penetration (in.)	Permanent deflection (in.)	Panel/door perforated (Y/N)	Observed damage	Passed test (Y/N)	Additional notes
R2	4-ply	107.8	1.5	<0.5	N	NA	Y	Impact at wall-wall connection (weak side)

Front of panel penetration.

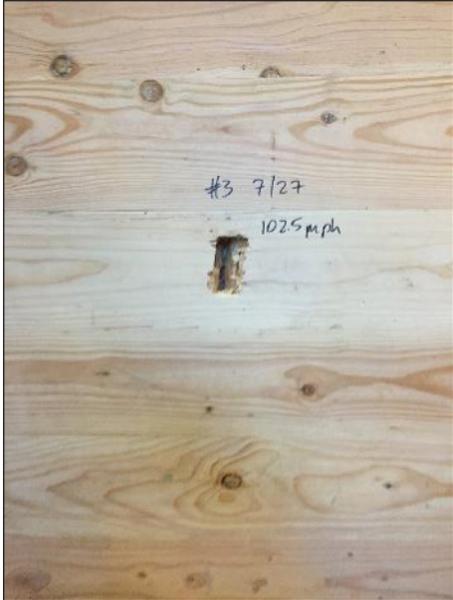
Test no.	Panel construction	Missile speed (mph)	Front penetration (in.)	Permanent deflection (in.)	Panel/door perforated (Y/N)	Observed damage	Passed test (Y/N)	Additional notes
R3	4-ply	102.5	2.5	<0.5	N	NA	Y	Impact at wall-wall connection (strong side)

Front of panel penetration.

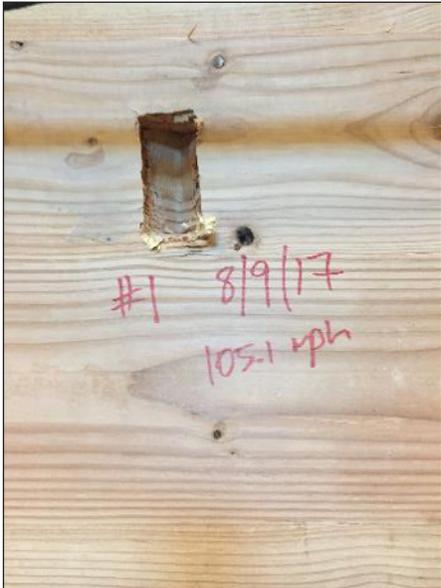
Test no.	Panel construction	Missile speed (mph)	Front penetration (in.)	Permanent deflection (in.)	Panel/door perforated (Y/N)	Observed damage	Passed test (Y/N)	Additional notes
R4	4-ply	105.1	1.5	<0.5	N	NA	Y	Impact at roof-wall intersection at top center of shelter

Front of panel penetration.

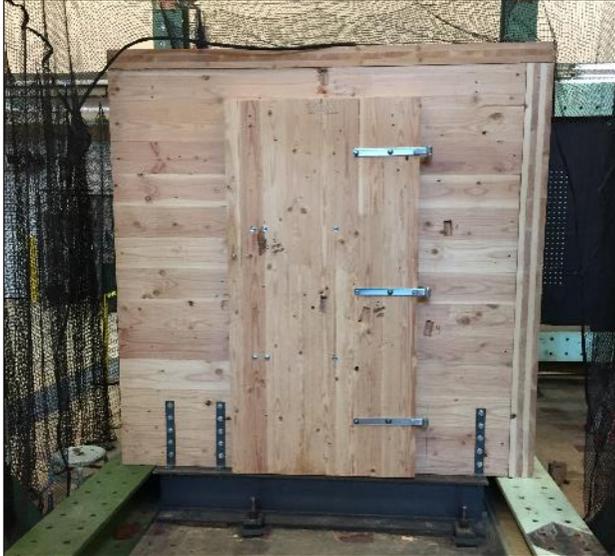
Test no.	Panel construction	Missile speed (mph)	Front penetration (in.)	Permanent deflection (in.)	Panel/door perforated (Y/N)	Observed damage	Passed test (Y/N)	Additional notes
R6	4-ply	114.0	0.8	<0.5	N	NA	Y	Impact at center of wall panel above door

Front of panel penetration.

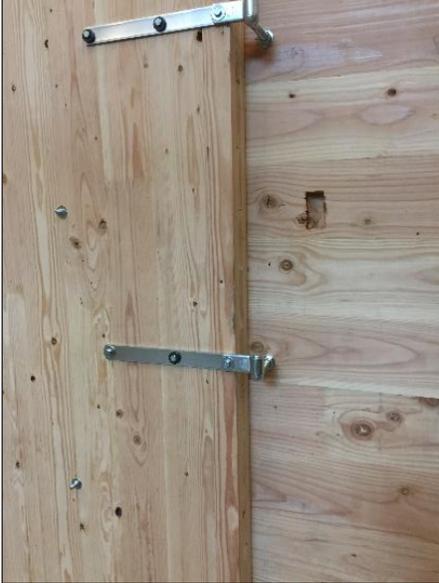
Test no.	Panel construction	Missile speed (mph)	Front penetration (in.)	Permanent deflection (in.)	Panel/door perforated (Y/N)	Observed damage	Passed test (Y/N)	Additional notes
R7	4-ply	106.4	1.4	<0.5	N	NA	Y	Impact on panel at door edge between upper hinges

Front of panel penetration.

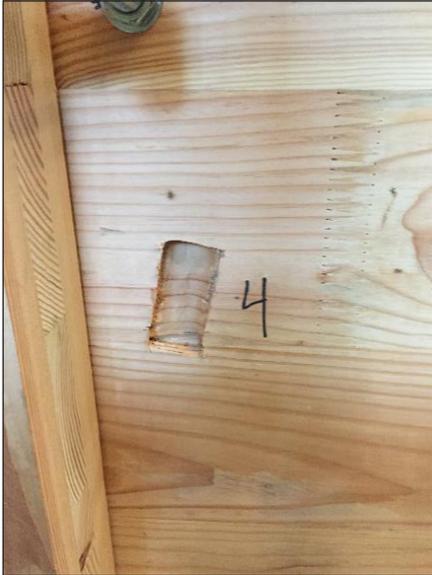
Test no.	Panel construction	Missile speed (mph)	Front penetration (in.)	Permanent deflection (in.)	Panel/door perforated (Y/N)	Observed damage	Passed test (Y/N)	Additional notes
R8	4-ply	102.2	0.5	<0.5	N	NA	Y	Impact on panel at door edge between door latches

Front of panel penetration.

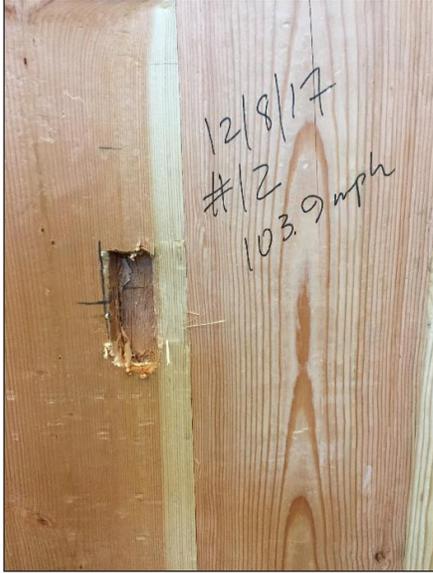
Test no.	Panel construction	Missile speed (mph)	Front penetration (in.)	Permanent deflection (in.)	Panel/door perforated (Y/N)	Observed damage	Passed test (Y/N)	Additional notes
S1	4-ply	103.9	1.5	<0.5	N	NA	Y	Impact to center of wall panel

Front of panel penetration.

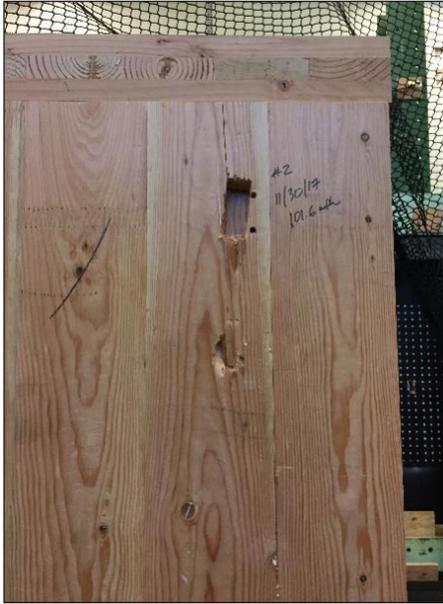
Test no.	Panel construction	Missile speed (mph)	Front penetration (in.)	Permanent deflection (in.)	Panel/door perforated (Y/N)	Observed damage	Passed test (Y/N)	Additional notes
S2	4-ply	101.6	1.0	<0.5	N	NA	Y	Impact at strong side of wall-wall connection

Front of panel penetration.

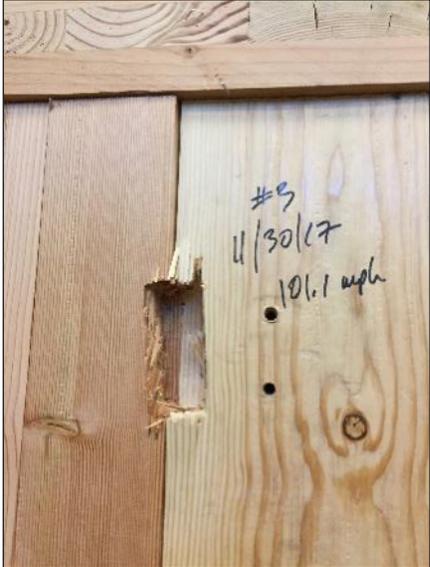
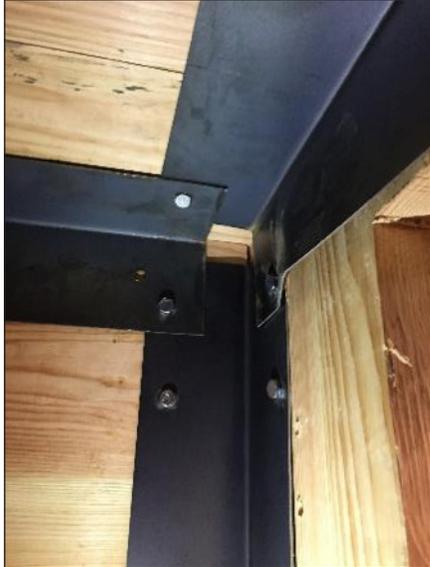
Test no.	Panel construction	Missile speed (mph)	Front penetration (in.)	Permanent deflection (in.)	Panel/door perforated (Y/N)	Observed damage	Passed test (Y/N)	Additional notes
S3	4-ply	101.1	1.1	<0.5	N	NA	Y	Impact at weak side of wall-wall connection; slight bending of sheet metal angle

Left to right: Front of panel penetration, slight bending of steel angle.

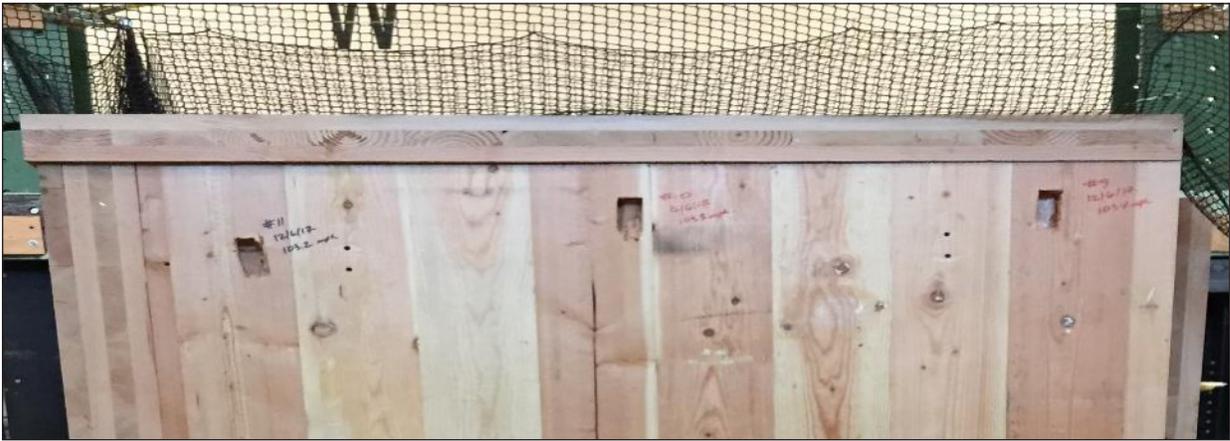
Test no.	Panel construction	Missile speed (mph)	Front penetration (in.)	Permanent deflection (in.)	Panel/door perforated (Y/N)	Observed damage	Passed test (Y/N)	Additional notes
S4	4-ply	103.4	1.5	<0.5	N	NA	Y	Impact at strong side wall-roof intersection at top of wall

Right impact in photo.

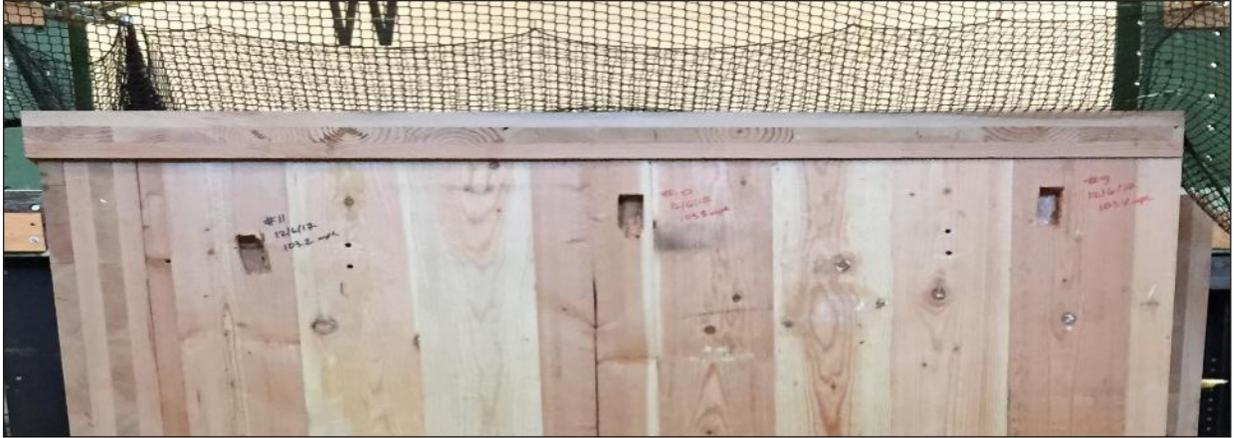
Test no.	Panel construction	Missile speed (mph)	Front penetration (in.)	Permanent deflection (in.)	Panel/door perforated (Y/N)	Observed damage	Passed test (Y/N)	Additional notes
S5	4-ply	103.3	1.5	<0.5	N	NA	Y	Impact at wall-roof panel intersection at center of wall panel

Middle impact in photo.

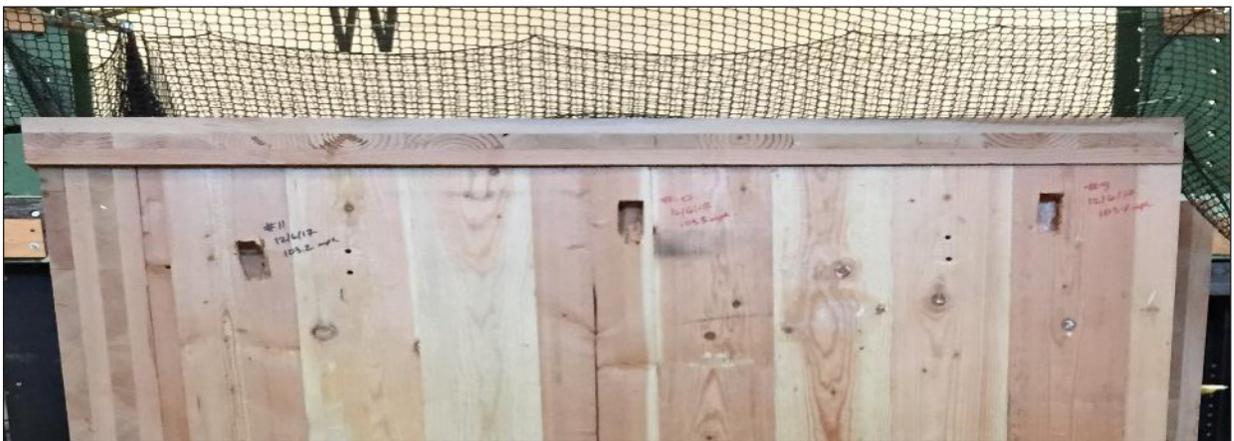
Test no.	Panel construction	Missile speed (mph)	Front penetration (in.)	Permanent deflection (in.)	Panel/door perforated (Y/N)	Observed damage	Passed test (Y/N)	Additional notes
S6	4-ply	103.2	1.5	<0.5	N	NA	Y	Impact at weak side of wall-roof intersection at top of shelter

Left impact in photo.

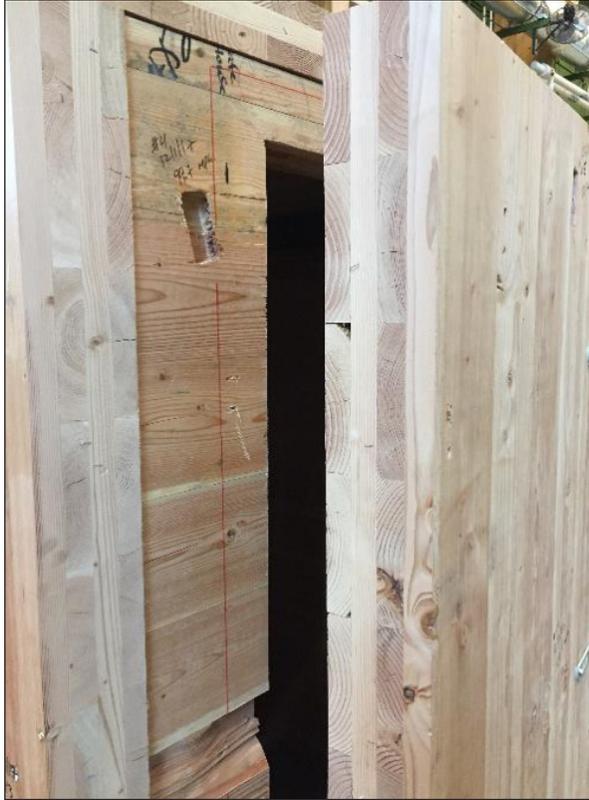
Test no.	Panel construction	Missile speed (mph)	Front penetration (in.)	Permanent deflection (in.)	Panel/door perforated (Y/N)	Observed damage	Passed test (Y/N)	Additional notes
S7	4-ply	99.7	0.8	<0.5	N	NA	Y	Impact at weak side wall panel next to door opening; speed was slightly below 100 mph, but test was deemed acceptable

Front of panel penetration.

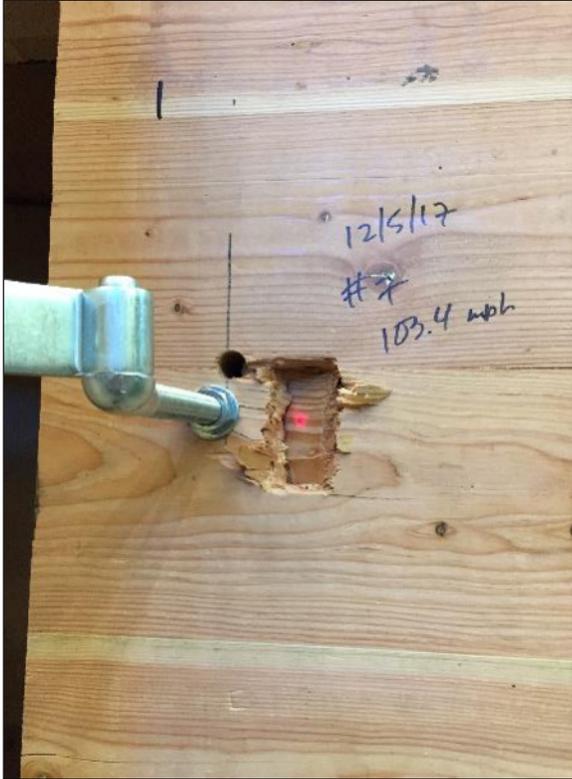
Test no.	Panel construction	Missile speed (mph)	Front penetration (in.)	Permanent deflection (in.)	Panel/door perforated (Y/N)	Observed damage	Passed test (Y/N)	Additional notes
S8	4-ply	103.4	1.5	<0.5	N	NA	Y	Impact at strong side wall panel next to door opening near top hinge

Front of panel penetration.

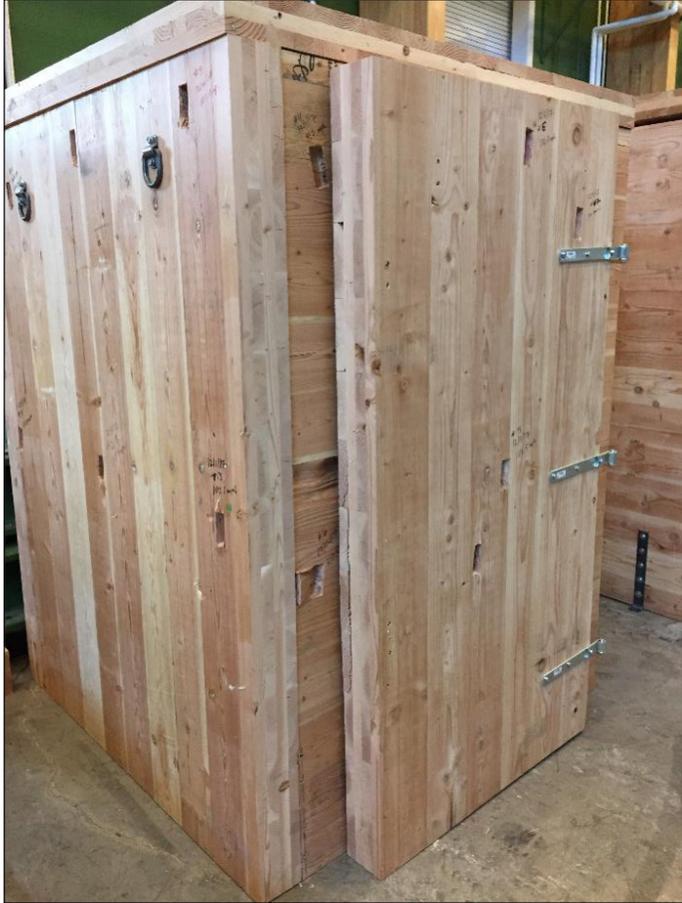
Test no.	Panel construction	Missile speed (mph)	Front penetration (in.)	Permanent deflection (in.)	Panel/door perforated (Y/N)	Observed damage	Passed test (Y/N)	Additional notes
S9	4-ply	102.4	1.3	<0.5	N	NA	Y	Impact at weak side wall panel next to door opening opposite middle hinge

Lower impact next to door in photo.

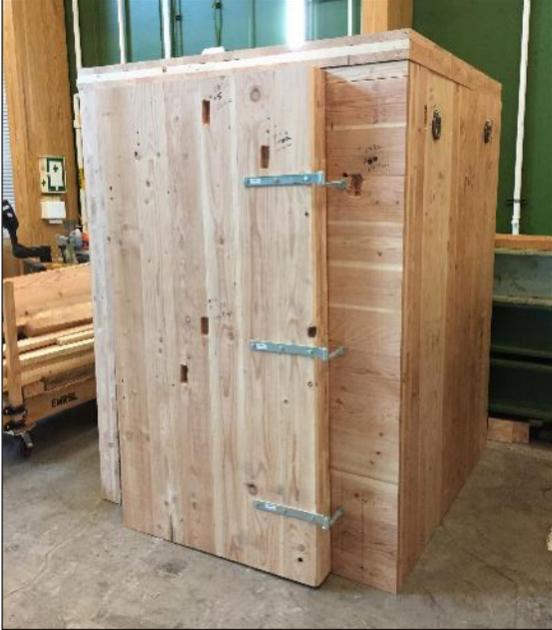
Test no.	Panel construction	Missile speed (mph)	Front penetration (in.)	Permanent deflection (in.)	Panel/door perforated (Y/N)	Observed damage	Passed test (Y/N)	Additional notes
DD1	4-ply	102.7	1.5	<0.5	N	NA	Y	Impact at upper center of door

Front of door penetration.

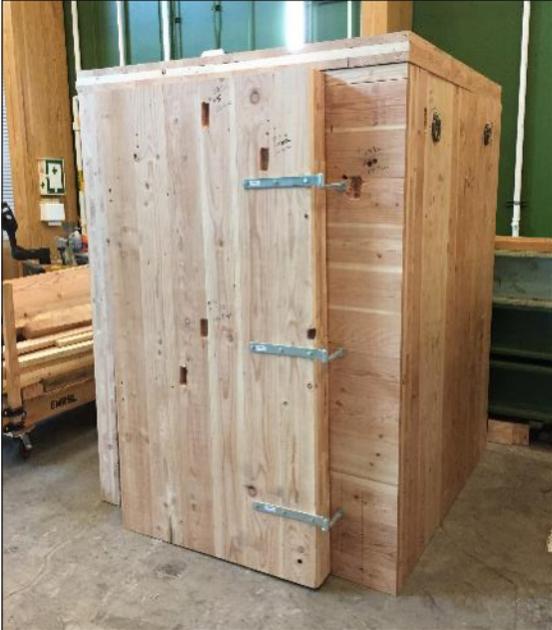
Test no.	Panel construction	Missile speed (mph)	Front penetration (in.)	Permanent deflection (in.)	Panel/door perforated (Y/N)	Observed damage	Passed test (Y/N)	Additional notes
DD2	4-ply	Not recorded	1.3	<0.5	N	NA	Y	Impact near upper hinge

Front of door penetration.

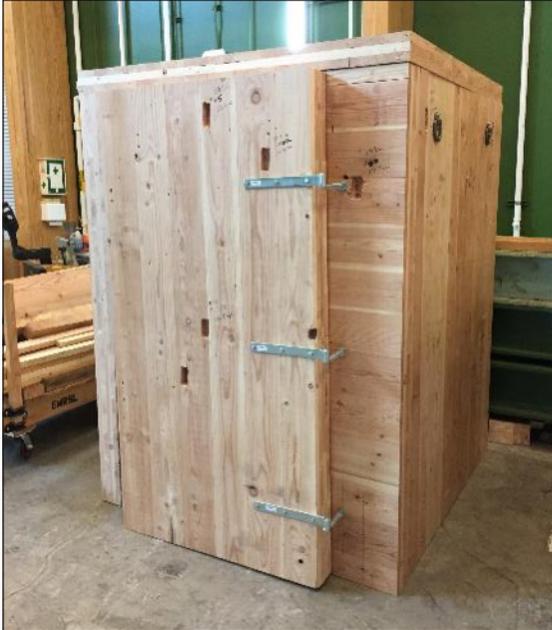
Test no.	Panel construction	Missile speed (mph)	Front penetration (in.)	Permanent deflection (in.)	Panel/door perforated (Y/N)	Observed damage	Passed test (Y/N)	Additional notes
DD3	4-ply	102.5	1.5	<0.5	N	NA	Y	Impact at geometric center of door

Front of door penetration.
