**Corrosion Immersion Testing of 13-mm-Diameter
Grade-10.9 Bolts for Bolt-on Armor**

ARL-CR-654

July 2010

14. ABSTRACT This experiment examined the performance of selected coatings and pretreatments on 13-mm grade-10.9 bolts immersed in a 5% NaCl solution in an attempt to evaluate the corrosion prevention properties of each selected coating and pretreatment relevant to those selected for bolt-on armor. Five candidate finishes as well as zinc plating in accordance with ASTM B 633 with hexavalent chromium conversion coating as control were tested. Each bath was heated to 75 °F, and the salt solution was agitated in order to prevent stagnation and ensure equal heating. Testing was completed over 500 h, with visual inspections and open circuit potential measurements at 1, 2, 4, 8, and 24 h, and once every 24 h following. In this experiment, corrosion creep was defined visually as frosting for the onset of corrosion and red rust in the percentage of the fastener affected, each yielding separate observations.

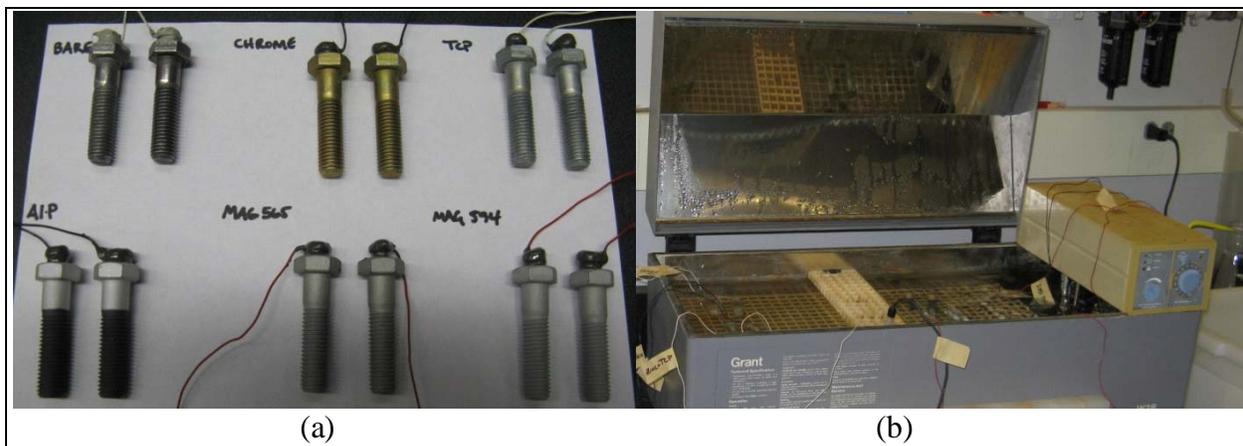
Figure 2. (a) Prepared bolts prior to immersion and (b) immersion bath setup.

1. Each bolt had a 1/8-in hole bored into the center of its head (see figure 1).
2. A Zn-plated steel screw, wrapped with wire, was fixed in place using this hole.
3. Polysulfide sealant was used to insulate and seal the wire/screw assembly to the bolt to prevent contamination (see figure 2 for full assembly).
4. A thermostatic circulated bath was filled with a 5% NaCl solution and heated to 75 °F. Solution temperature was maintained for the duration of the experiment, and the water was continually agitated.
5. Two of each specimen were immersed in the bath for 500 h. Open circuit potential measurements and visual inspections were taken after 1, 2, 4, 8, and 24 h, and every 24 h thereafter.

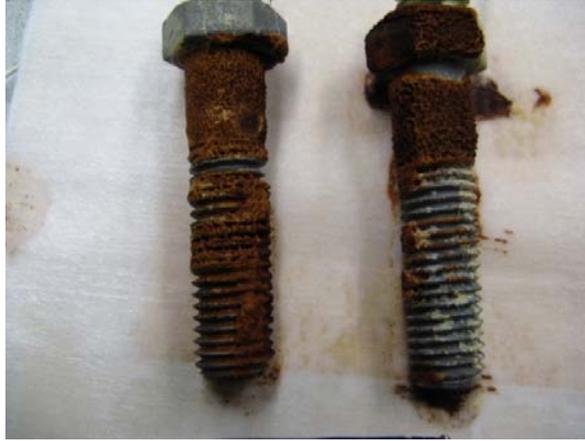
Figure 5. Bare bolts immediately after immersion.

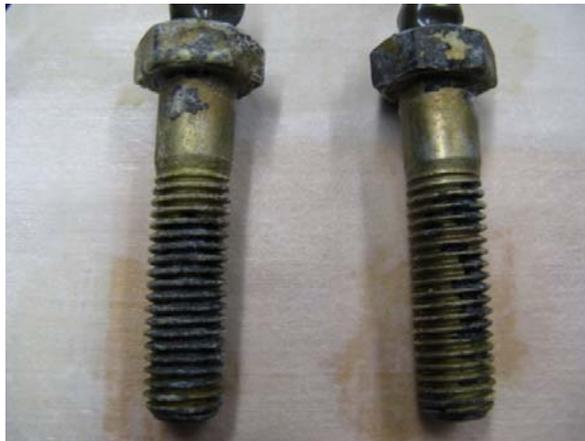
Figure 6. Hexavalent chrome/zinc bolts immediately after immersion.

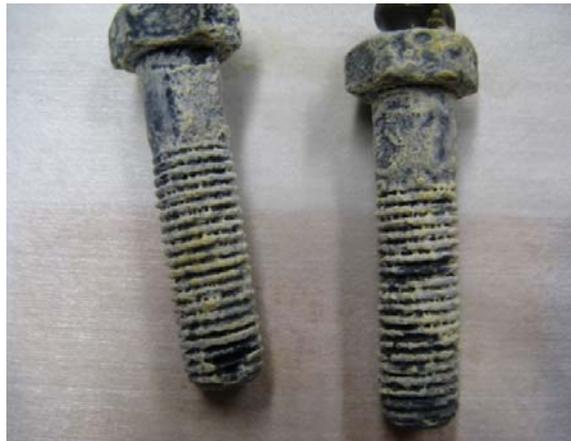
Figure 7. TCP/zinc bolts immediately after immersion.

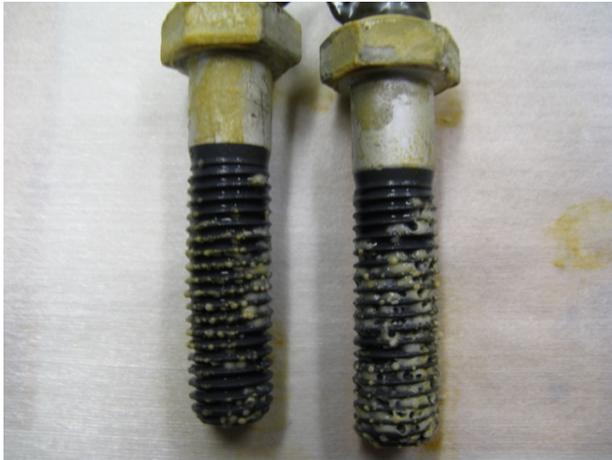
Figure 8. AlumiPlate bolts immediately after immersion.

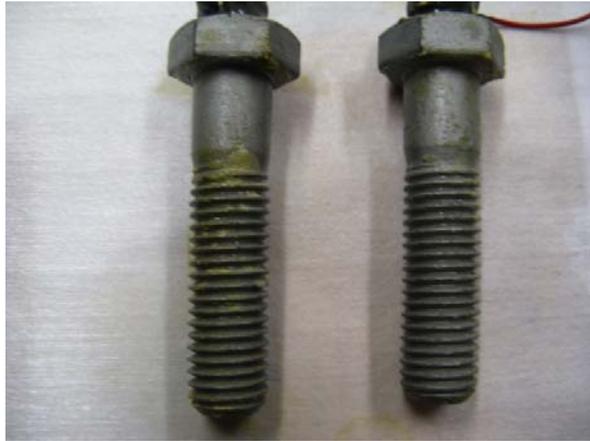
Figure 9. MagniPlate 565 immediately after immersion.

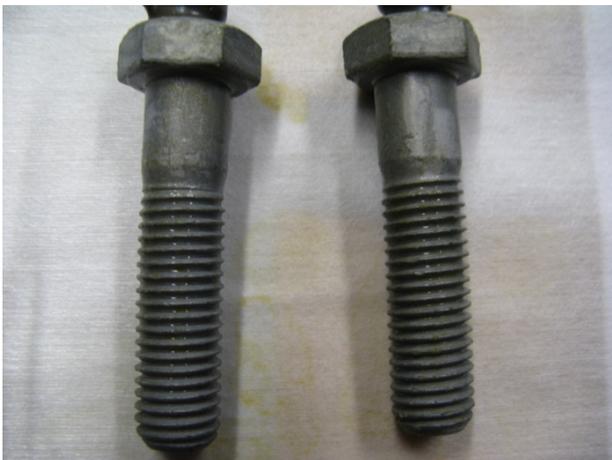
Figure 10. MagniPlate 594 immediately after immersion.

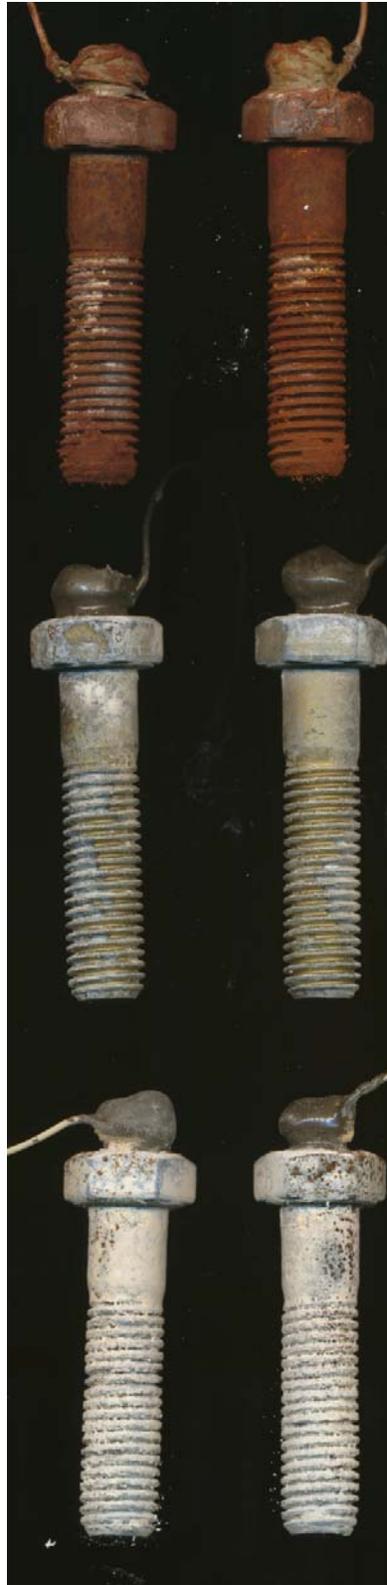
Figure 11. Bare steel, hexavalent chrome/zinc, and TCP/zinc after drying.

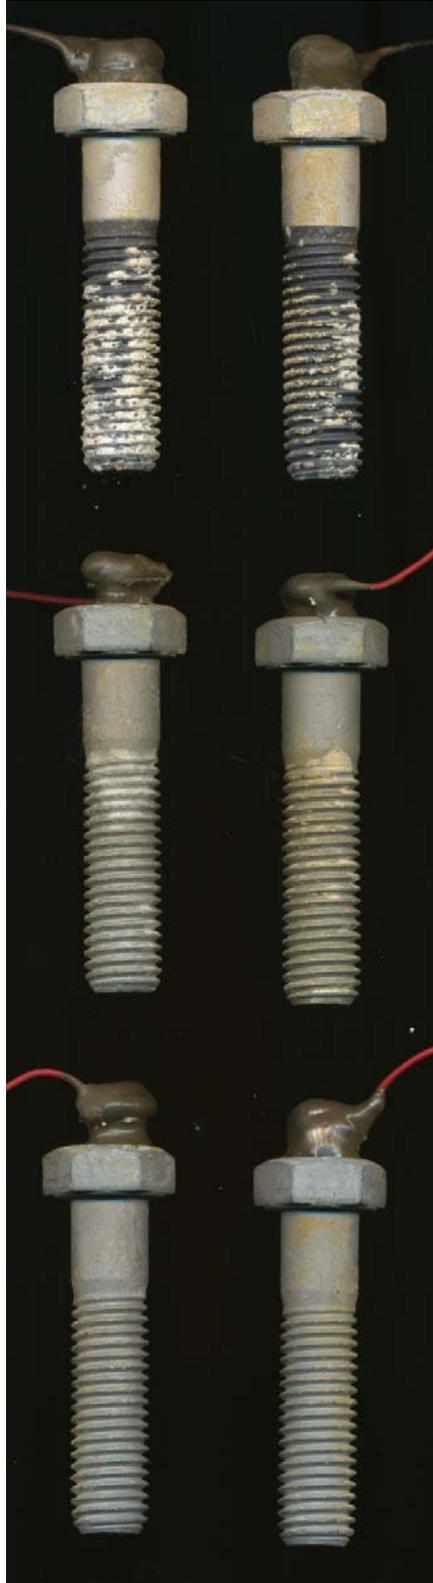
Figure 12. AlumiPlate, MagniPlate 565, and MagniPlate 594 after drying.

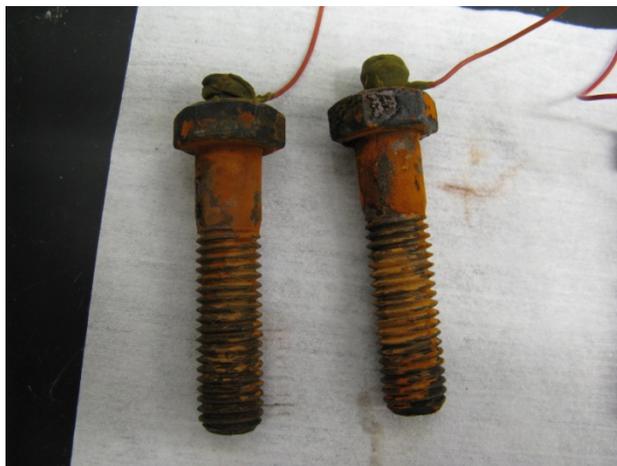
Figure 15. Bare bolts immediately after immersion in supplementary experiment.

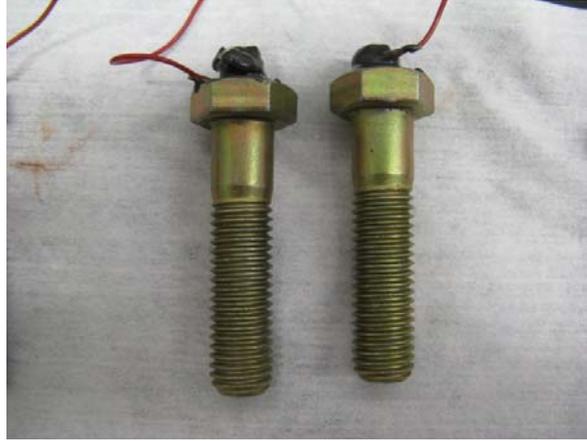
Figure 16. Hexavalent chrome/zinc bolts immediately after immersion in supplementary experiment.

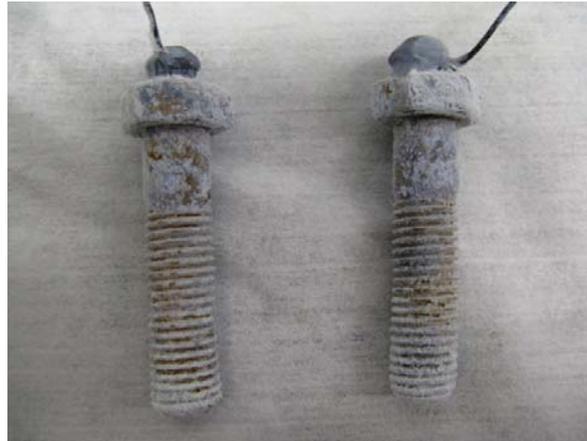
Figure 17. TCP/zinc bolts immediately after immersion in supplementary experiment.

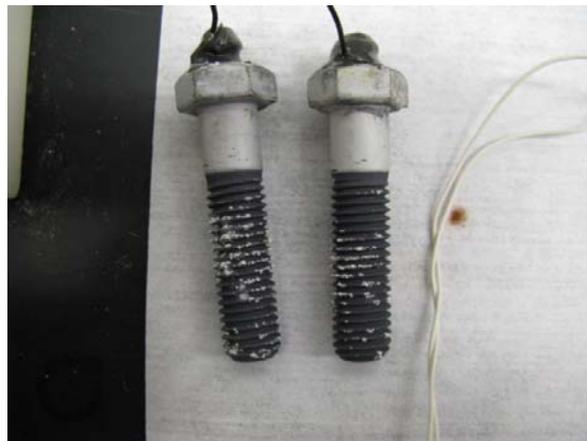
Figure 18. AlumiPlate bolts immediately after immersion in supplementary experiment.

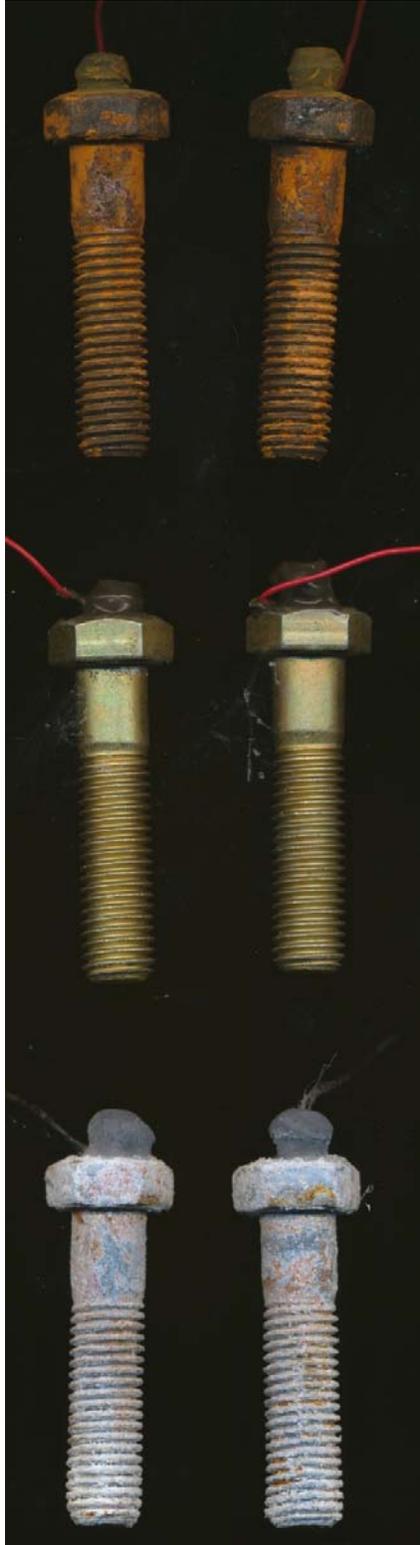
Figure 21. Bare steel, hexavalent chrome/zinc, and TCP/zinc after drying in supplementary experiment.
