ARL-TN-0890 • June 2018

Effect of Porosity on Synthetic Sand Infiltration within Yttria-Stabilized Zirconia Pellets

by Andrew Wright, Michael Walock, Andy Nieto,
Anindya Ghoshal, Jian Luo, and Muthuvel Murugan

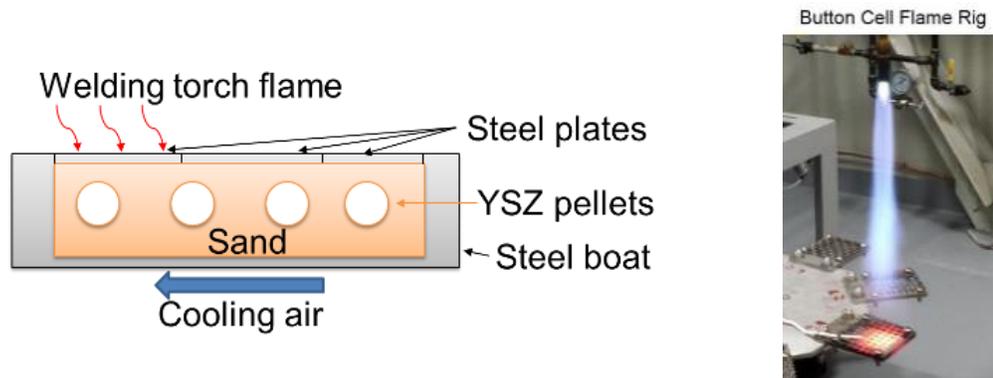
Fig. 1 a) Schematic of BCFTR experimental setup; b) photo of welding torch in relation to holder

The experimental setup used to induce sand infiltration within the YSZ pellets is shown in Fig. 1, named button cell flame test rig (BCFTR).

A steel boat was prepared by packing it with synthetic sand (AFRL-02, Powder Technology Incorporated, MN) and burying a few YSZ pellets within the sand. Three thin metal plates were placed across the top of the boat to prevent sand from spraying out due to the velocity of the torch. The welding torch was positioned approximately 2 ft above the steel boat. Once the welding torch was ignited, the flame was adjusted so that the flame was concentrated on 1 of the 3 metal plates. Each metal plate was exposed to the flame for 15 min for a total runtime of 45 min. The height of the welding torch in relation to the boat was also adjusted to control the temperature. The temperature was controlled by checking a dual wavelength

pyrometer measuring the surface temperature of the tested steel plate. The height of the torch was adjusted manually and pyrometer temperature was inspected visually so that it was approximately 1300 °C—no automatic controller was set. Compressed air was blown on the underside of the boat by an air knife to provide backside cooling as seen in turbines.

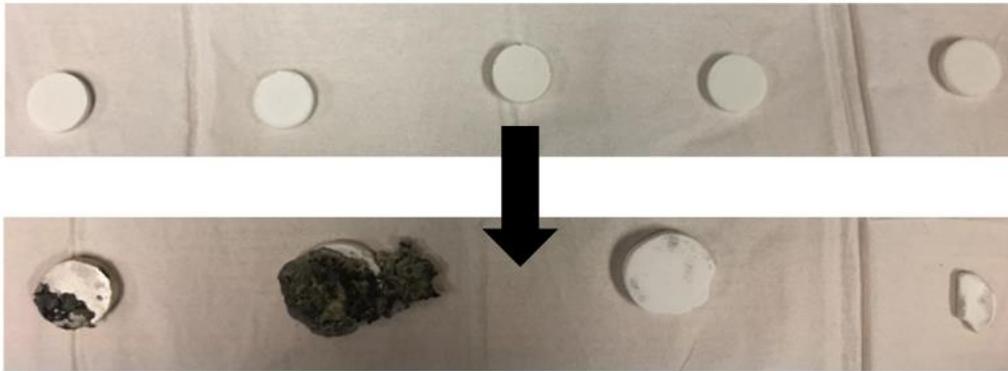
Fig. 2 a) Pretest and b) posttest images following sand testing. Large deposits are clearly seen in some of the samples while others only show signs of infiltration through color changes.

The synthetic sand was previously known to melt around 1100 $^{\circ}\text{C}$.⁸ A 15-min exposure time at 1300 $^{\circ}\text{C}$ was shown to provide ample CMAS interaction with the pellets. This was seen visually through the pretest and posttest photos in Fig. 2.

Preceding testing, all pellets were white, with thicknesses varying from 1–6 mm, and diameters varying from 6–25 mm. Following testing, changes in the form of glassy, siliceous deposits or gray infiltration regions are seen in all samples, regardless of density. No preference for deposit formation based on density was noticed, however.

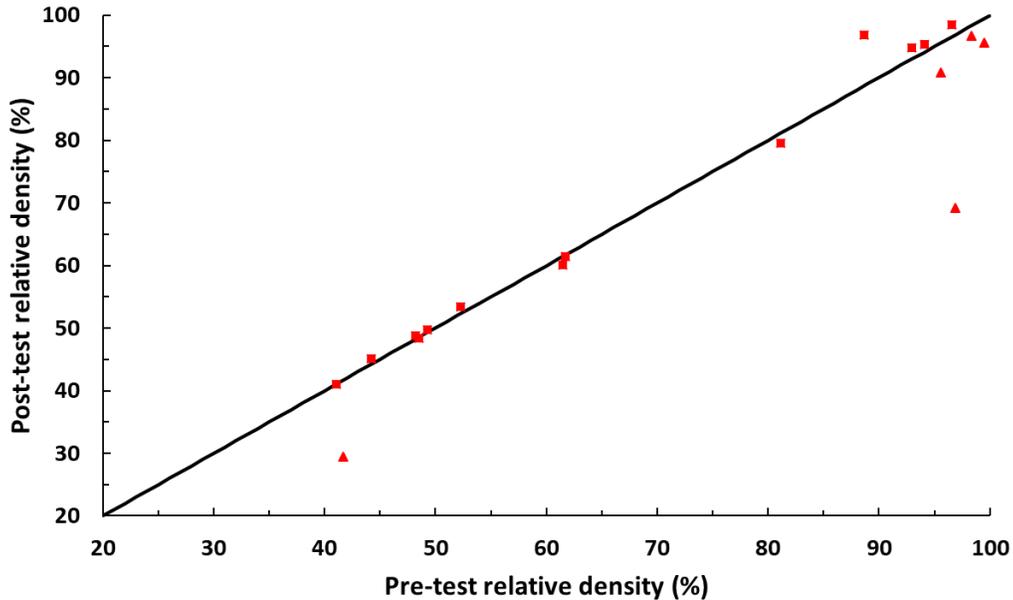
Fig. 3 Comparison between pretest and posttest densities. Black, $x = y$ line represents no change in density following testing. Data points denoted with red triangles signify samples with significant CMAS deposition.

This can only be applied assuming there are no deposits on the surface. The samples with significant deposit formation were treated no differently than the pellets without deposits. This was done to not disturb the microstructure at the CMAS-YSZ interface. Disruption may involve CMAS withdrawing from the YSZ and leaving empty pores. The comparison between the densities preceding and following testing is shown in Fig. 3.

Nearly all points fall within the error of $\pm 2\%$ of the $x = y$ line. Significant decreases in density are due to samples bearing large, porous surface deposits that are primarily composed of silica, which is less dense than YSZ. No substantial differences are seen between the low- and high-density samples.

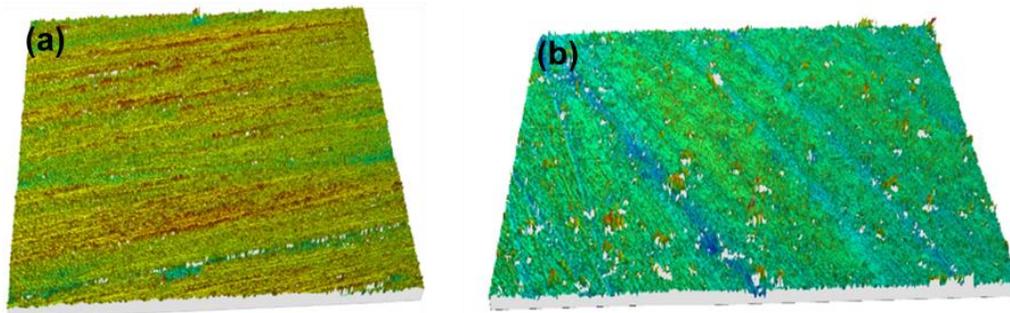
Fig. 4 a) Pretest and b) posttest surface maps of a high-density (93.0%) pellet. Small peaks in the post image are suggested to be randomly distributed sand deposits.

The surface roughness and degree of isotropy was examined for each of the pellets before and after testing using a C-LSM. Topographical maps of area $300\ \mu\text{m} \times 300\ \mu\text{m}$ were reconstructed using Z-scan imaging. Examples of the surface maps are shown in Fig. 4.

Surface roughness values were calculated in accordance to the ISO 25178.⁹ In this example, the surface roughness was seen to increase from 0.548 to 0.593. This can be identified through the numerous plateaus seen in the posttest image arising from small silica deposits on the surface. The degree of isotropy was also measured for each of the samples and using this example the value increased from 10.212% to

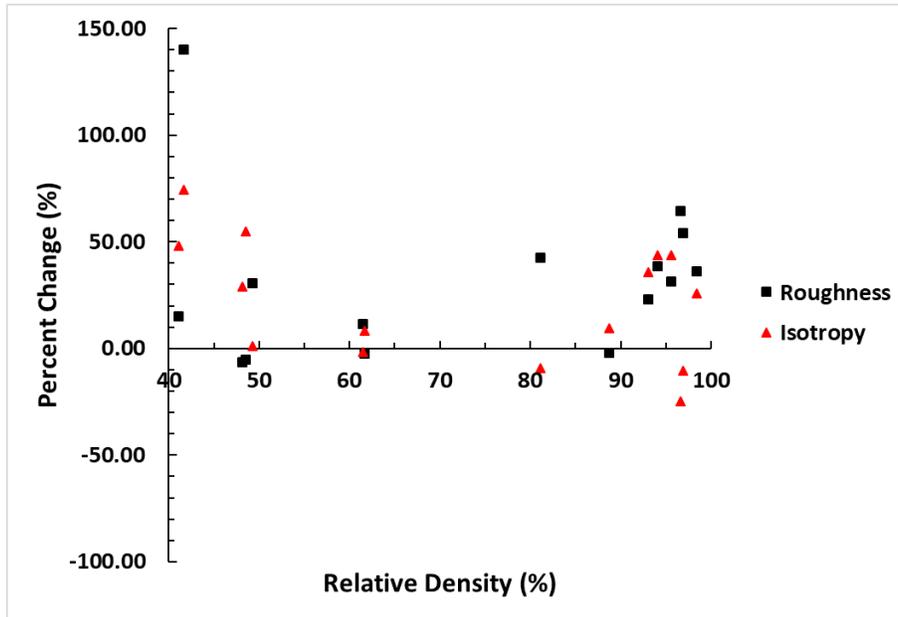
Fig. 5 Percent change in surface roughness and isotropy as a function of relative density. An increase in both variables is discerned.

17.353% following testing. An increase in surface roughness and isotropy was a general trend that was seen in nearly all samples, regardless of density, as shown in Fig. 5.

An increase in both variables could be attributed to a scenario where sand deposits are forming on the surface at random with no preference to previous deposit locations or areas of greater activity. A random distribution of deposits would increase surface roughness by introducing greater height differences within the sample and the isotropy would increase due to the random distribution of the deposits. While there was a general increase in both variables across all densities, Fig. 5 seems to suggest that low-density samples experience higher degrees of isotropy increase while high-density samples experience higher surface roughness gains. A possible explanation is that in high-density samples the sand deposits form near each other on flat surfaces, away from valleys, while in low-density samples the sand deposits form within the valleys (not near each other).

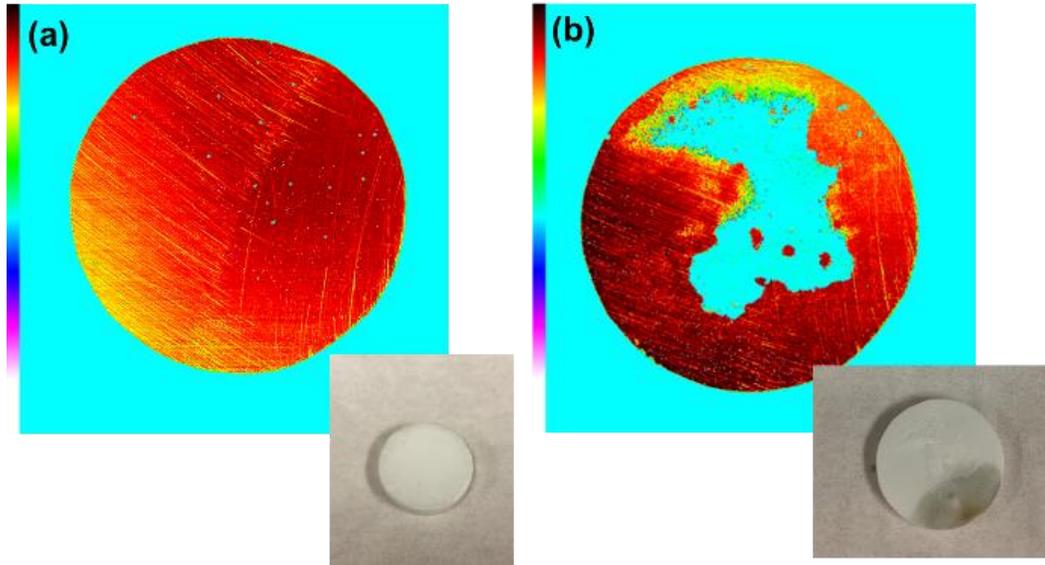
Fig. 6 a) Pretest and b) posttest SAM surface maps along with optical images of a 93.0% dense pellet. A white sand deposit is seen spanning across the surface while heavy sand infiltration (seen as discoloration) is discerned in the posttest sample. The color map corresponds to elevation (small time of flight) in the sample with red/black, purple, and light blue representing high elevation, low elevation, and no signal, respectively. No signal rises from either scattering (from rough sand deposits) or bubbles on the surface (high attenuation in air).

While C-LSM was used to determine surface roughness and isotropy on a micron-sized scale, the SAM was used to get a detailed macroscopic view of the surface. The SAM featured a 100-MHz transducer that was raster scanned across the sample to provide a surface map. Figure 6 shows a case of a high-density (93.0%) sample.

Grinding patterns are easily distinguishable in the pretest image along with small blue dots, which are due to bubbles forming on the surface during the scan. Following testing, a large white sand deposit was seen, optically and through the SAM, across the surface. The deposit appears as no signal because, due to the height, the deposit was out of focus and the acoustic waves are scattered away from the detector located in the transducer. Grinding patterns are still discerned; however, the gradient is flipped and appears of greater magnitude within the YSZ surface. This may be due to deposits on the backside or because the surfaces of the pellets were not flat. The discolored region denoting infiltration does not seem to have a noticeable effect on the surface topography of the sample. Grinding lines are still, with near same resolution, visible as in the pretest image suggesting very little (i.e., thin) deposit formation occurred and sand primarily diffused through this sample. This technique was performed for all samples; however, no differences were seen between the high- and low-density samples that the C-LSM did not already identify.

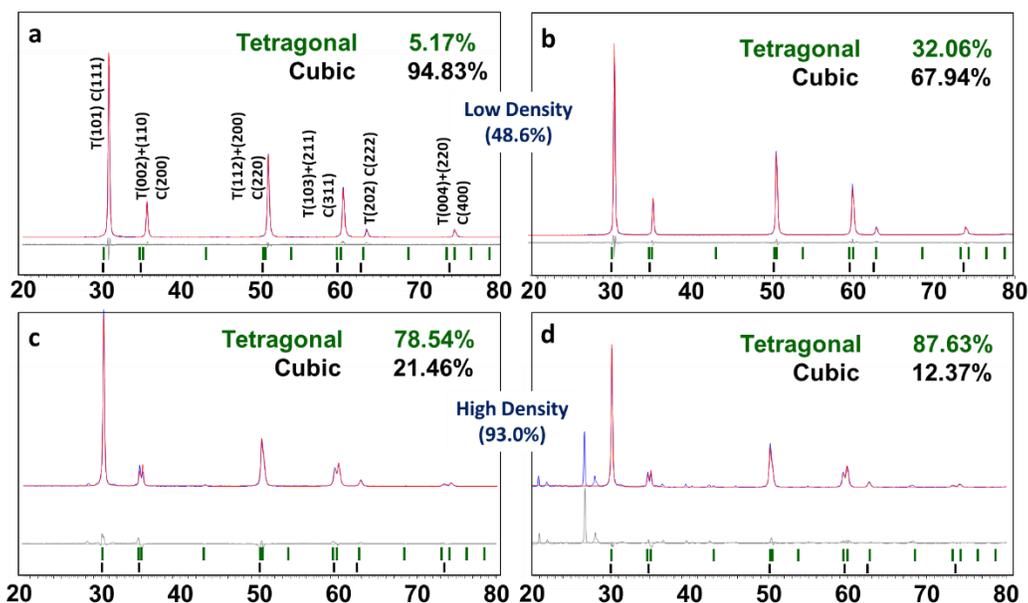
Fig. 7 Rietveld-analyzed XRD patterns for a (a, b) low- and (c, d) high-density sample with (a, c) pretest and (b, d) posttest patterns to see the effects of CMAS testing. Blue, red, and gray patterns represent experimental, Rietveld fitting, and the difference between the two, respectively. The green and black dashes below the curves are the simulated peak positions for the tetragonal and cubic phase. The composition of the low- and high-density sample are 8YSZ and 4YSZ, respectively.

contamination). For each XRD pattern, Rietveld refinement was carried out to get an idea on the ratio of tetragonal to cubic phase of YSZ within the samples. The Lorentzian crystallite size and strain were also refined for each tabulated pattern. This was done to gain insight on peak broadening and shifts that may occur. Figure 7 shows the pretest and posttest XRD patterns for a low- and high-density sample.

Three features to note are the addition of new phases, peak shift, and the change in tetragonal to cubic phase ratio. A few new peaks are seen in the high-density sample around 21, 27, and 29° 2θ. These new peaks are suggested to be attributed to quartz and cristobalite. Negative peak shifts were examined for both samples but the magnitude of the shift is different. The 48.6% dense sample experienced a 0.2° 2θ shift while the 93.0% dense sample negatively shifted 0.05° 2θ. A majority of the samples underwent a negative shift following testing with only a couple of them shifting positively. Positive and negative peak shifts are usually suggested to be due to compressive and tensile strain,¹⁰ respectively. Lastly, an increase in the tetragonal phase content was seen for both pellets. It might be expected that the cubic content would rise for the low-density sample (8YSZ) due to the tetragonal to cubic phase transition around 1150 °C. However, in the low-density sample the infiltrated silica may provide preference for the tetragonal phase to form by

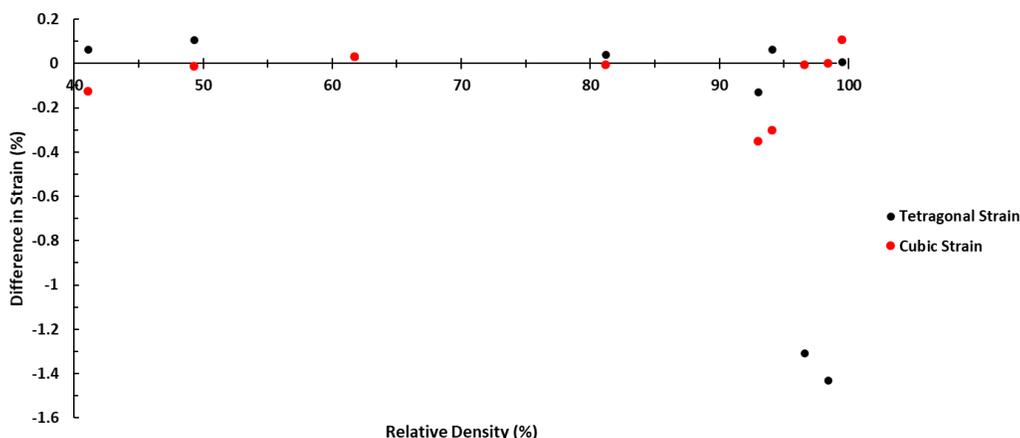
Fig. 8 Change in strain for both the tetragonal and cubic phase for all pellets. Data was collected through the Rietveld-analyzed XRD patterns.

Further analysis of the Rietveld-refined data was focused on the strain within the samples. Figure 8 shows the change in strain in the tetragonal and cubic phase of each sample following testing. Although the low-density samples seem to have very little changes in strain, the high-density samples appear to have a large decrease in their strain following testing. This could be due to leaching of Y^{3+} out of the YSZ crystal structure and reacting with Si to form a yttrium silicate phase. This phenomenon has been examined and studied in the solid oxide fuel cell field¹¹ as yttrium loss leads to significant decreases in ionic conductivity. Continual removal of yttrium ions from YSZ will lead to phase changes as pure zirconia will form at the surface of the grains in contact with the CMAS intergranular film at the grain boundary. The strain produced here may be significant but it is hard to conclude with only XRD data. Dedicated strain experiments need to be made using a strain gauge or a similar instrument to arrive at a more definitive claim.

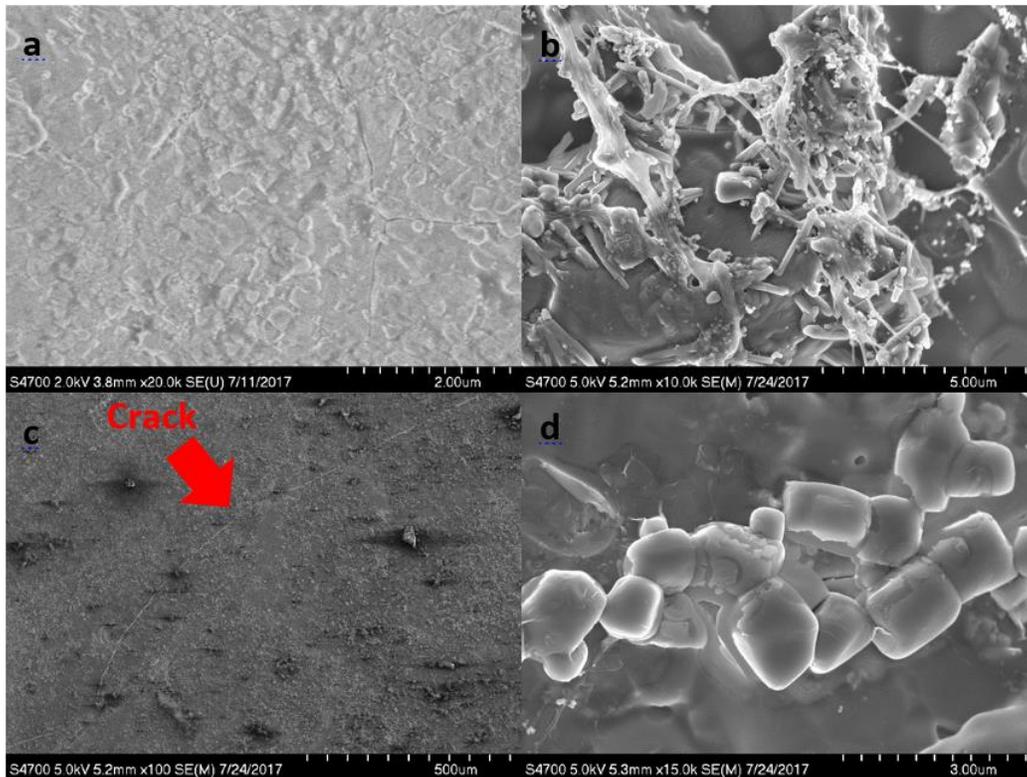
Fig. 9 a) Surface micrograph of a 93.5% density pellet preceding testing. Posttest SEM surface images of the same pellet at different magnification: b) closeup of the sand deposit shows fiber-like strands, which may indicate partial melting; c) a crack of about 30 nm spans across the surface and is discerned as a white line (highlighted by a red arrow); d) at increased magnification, particles are shown to agglomerate along the site of the crack. These particulates are likely to be YSZ grains that have become dislodged from the pellet during thermal cycling since they are consistent in size and morphology of the preexisting grains.

SEM was used to investigate the microstructure of YSZ pellets exposed to molten sand during the flame test. Figure 9 details a few of the images taken on the top surface of the pellet before and after testing of a high-density (93.5%) sample.

In the initial image (Fig. 9a) the surface is clean, a grain size of about 1 μm can be discerned, and a microcrack is visible on the right side of the image, which most likely formed during processing. Following sand testing, deposits can be seen on the surface in Figs. 9b and c. Particularly in Fig. 9b, fiber-like strands are seen within a deposit adhered to the YSZ surface. This suggests that the sand is undergoing partial melting and, upon cooling, creating these thin fibers. Several of the deposits, which are littered across the surface, exhibit these same characteristics. The knowledge of partial liquefying can help tremendously on pinpointing exact mechanisms of infiltration through further testing. A crack is also discerned on the surface as a white line, and upon increased magnification the white lines appear as structures near or covering the crack as seen in Fig. 8d. These structures are likely to be YSZ grains that have become dislodged during the flame test (thermal cycling). The YSZ grains ($\sim 1 \mu\text{m}$), which can be seen in the background of Fig. 9b, do not have the same morphology as the sand deposits, which have more irregular shapes, fiber-like strands, and smaller particles adhered

to them. These structures are also seen throughout the entire length of the crack and appear nowhere else on the surface, suggesting that it was a localized phenomenon. These features were also not found in any other sample.

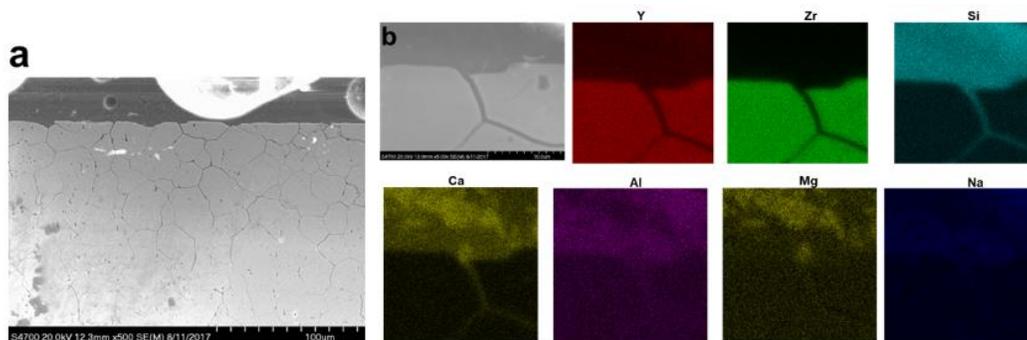
Fig. 10 a) SEM image of a highly dense (99.5%) YSZ sample exhibiting infiltration. The dark contrast at the top of the image is a sand deposit. b) EDS analysis of the infiltration showing Si and Ca to be the main infiltrators.

Sand infiltration was also seen penetrating through cracks of a highly dense (99.5%) sample as seen in Fig. 10a. The dark contrasts seen throughout the photo are siliceous compounds penetrating through cracks of the sample, which may be at the site of grain boundaries. This is not suggested to be every grain boundary, as the sizes of these “grains” are too large (~10–20 μm) to be consistent with previous grain sizes on the order of 1 μm . Elemental analysis of the penetration was obtained through EDS, shown in Fig. 10b. The infiltration is clearly shown to be attributed to Si and Ca while the surrounding material is YSZ. Al seems to have partially infiltrated while Mg and Na show very little signs of infiltration. This clearly shows one mechanism of infiltration. If cracks are already present within the sample, which could be formed through thermal expansion, then sand can potentially enter through these sites and fill in the gap. For interactions occurring on the atomic scale, a transmission electron microscopy analysis is needed. It is unknown whether these cracks were present before or after testing. These images are also directly below a sand deposit that formed on the surface, which could have also formed these cracks during testing.

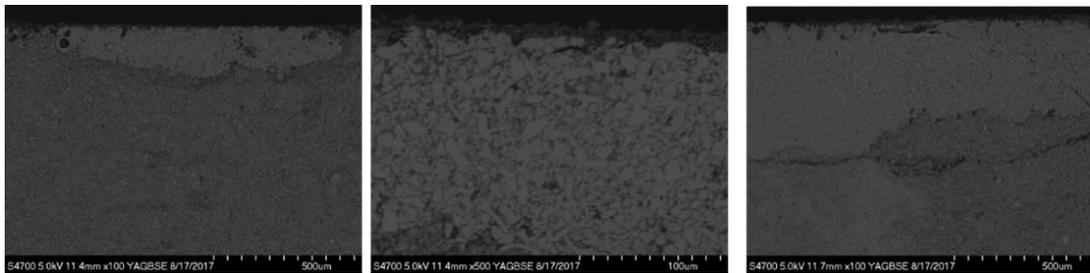
Fig. 11 Back-scattered SEM images of a low-density (61.5%) sample showing 3 different contrast regions: a) 100× magnification of a 3-contrast region; b) increased magnification (500×) of a spot in 11a; c) another, larger 3-contrast region approximately 2 mm to the right of 11a. They are suggested to be dark: Si-rich, light: Zr-rich, and medium: bulk YSZ.

Another potential mechanism of infiltration (mentioned earlier) involves leaching of Y or Zr out of the crystal structure to form a new compound with Si. Figure 11 shows a few back-scattered SEM images showing great contrast between the bulk YSZ and a suggested Zr-rich phase, due to the lighter contrast. The darker region on top of the lighter region is suggested to be CMAS or Si-rich phases while the bulk is the 4YSZ. This sample has significant porosity (61.5% dense) giving the added capability of the CMAS to infiltrate and particles or atoms to shift around. No elemental analysis has been conducted on this sample yet so these statements

are still speculations. However, if proved correctly, leeching could provide another mechanism of failure by perhaps the weakened structural support of the new Zr-rich phase. SEM analysis provided significant insight on potential mechanisms of infiltration and destruction. However, the results observed were consistent on nearly all samples; no disparities were seen between high- and low-density specimens. Deposits and infiltration sites were present on the majority of samples (as was shown earlier) and on the microscale, the structures and morphology appear to be independent of density.
