Amtrak Passenger Train 501 Derailment
DuPont, Washington
December 18, 2017

Accident Report

NTSB/RAR-19/01
PB2019-100807

National
Transportation
Safety Board

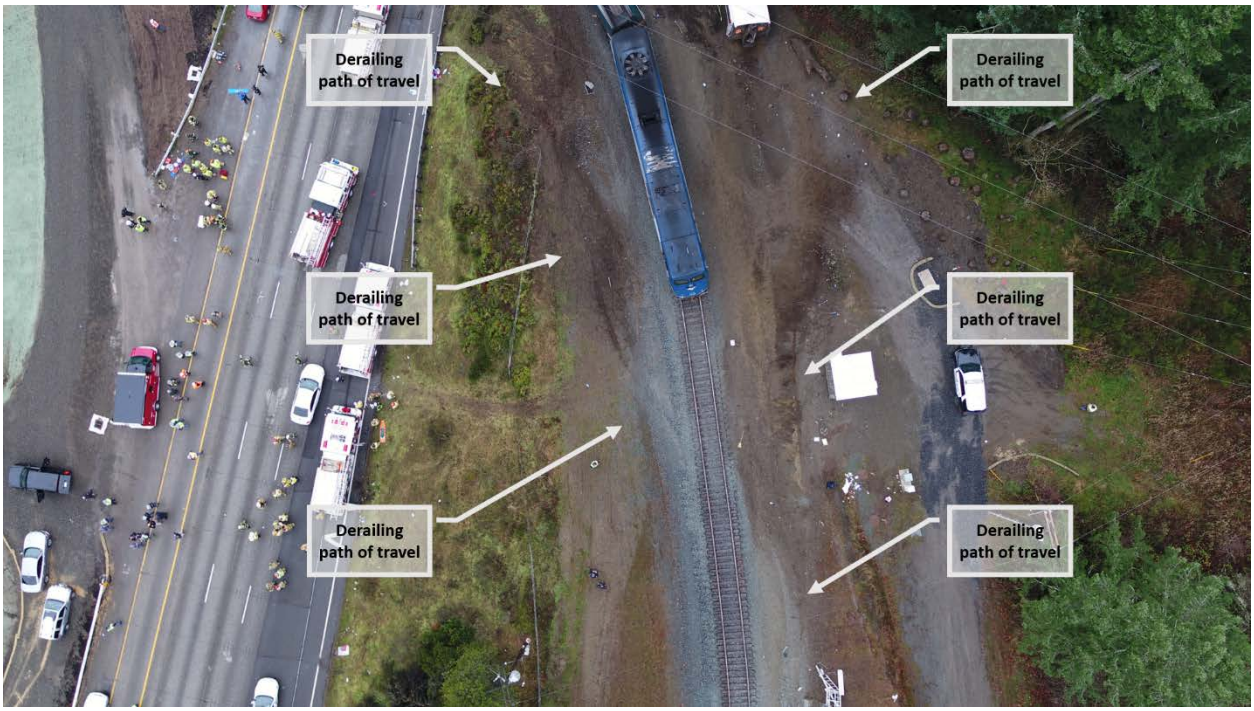
The railcars trailing behind AMTK 7422 (10) then traveled to the left of the main track. In the aerial photograph visible marks in the ballast and soil show the path of travel of the separated train. (See figure 14.)

Figure 14. Derailing path of travel of Amtrak 501. (Photo provided by WSP.)

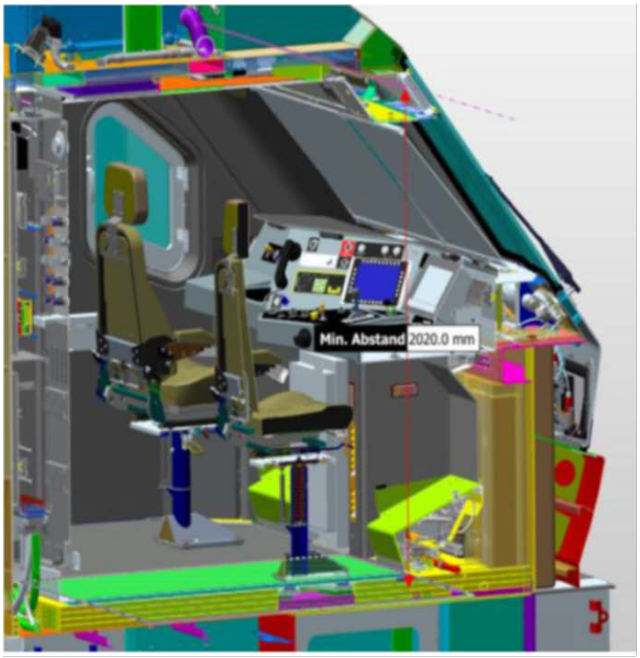
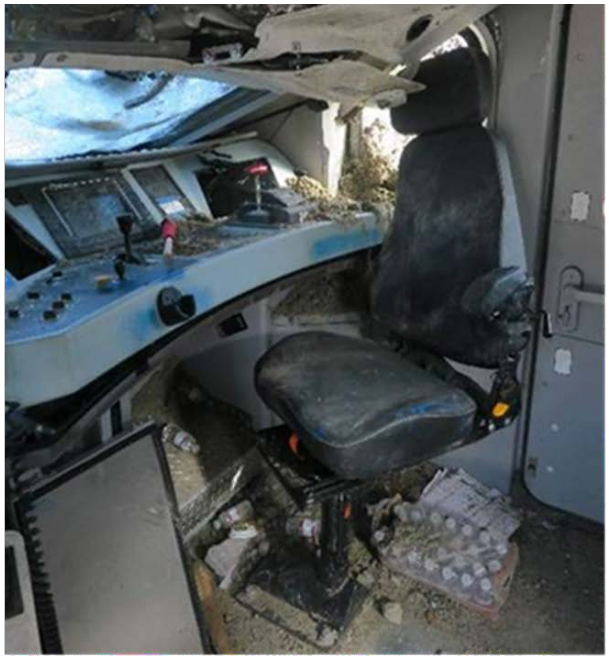
Damage to the interior of the operating cab was constrained primarily to the leading end, most notably at and above the front glazing (windshield). The vertical space of the cab interior was reduced to about 19 inches between the operator's desk and the ceiling, and to 66 inches from the floor to the ceiling. The height above the seats was reduced to 66.5 inches. All doors, both side doors, and the machinery room access door, were fully functional after the accident. The cab ceiling emergency exit hatch was dislodged from the vehicle. The hatch is comprised of two parts; the upper, or outer, part came to rest in the wooded area between the track and the interstate, and the inner portion was inside the cab. Investigators estimated the locomotive lost about 5 percent of its occupied volume in the cab. Figure 19 is a cutaway illustration of the locomotive cab showing the cab design and underlying structure and an interior photograph of the accident cab taken from the left side of the cab towards the engineer's seat on the right.

Figure 19. Pictures of the cab design and cab damage. (Photograph courtesy of Siemens.)

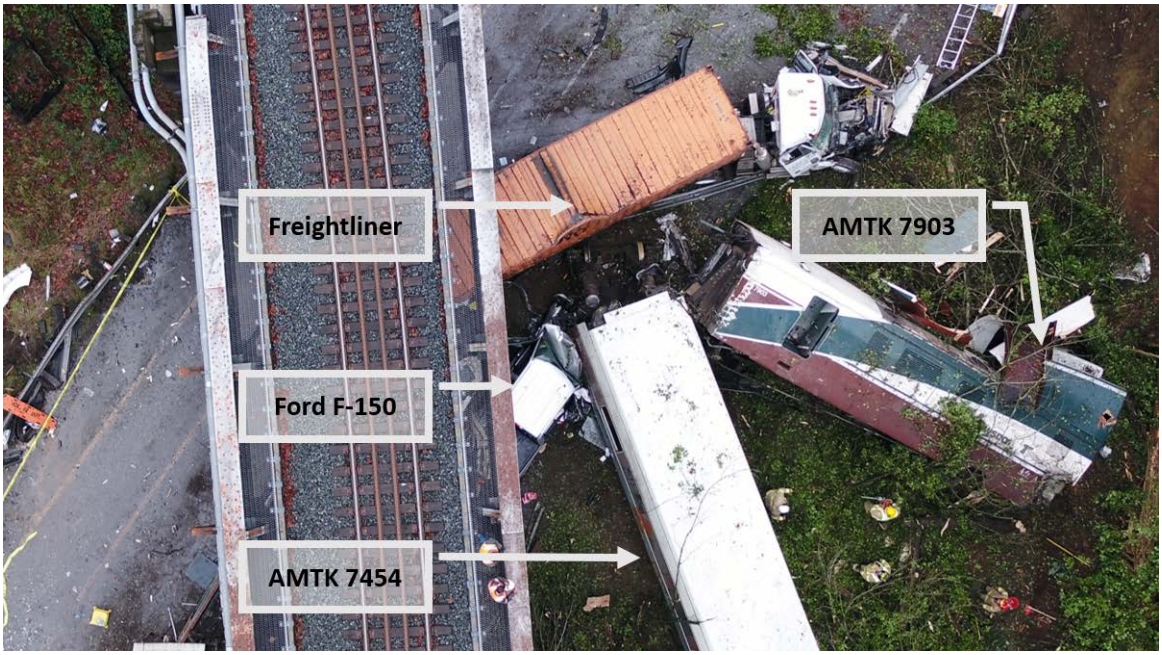
A Ford F-150 pick-up truck was damaged when AMTK 7454 (3) entered the roadway south of the overpass in front of it. The driver reported that he was unable to stop and struck the railcar. AMTK 7424 (8) collided with the rear of the truck as it slid to a stop on the interstate. The driver sustained severe injuries as did the front-seat passenger, who was trapped in the vehicle and had to be extricated by the first responders. (See figure 24.)

Figure 24. Final resting position of F150 and Freightliner. (Photo provided by WSP.)

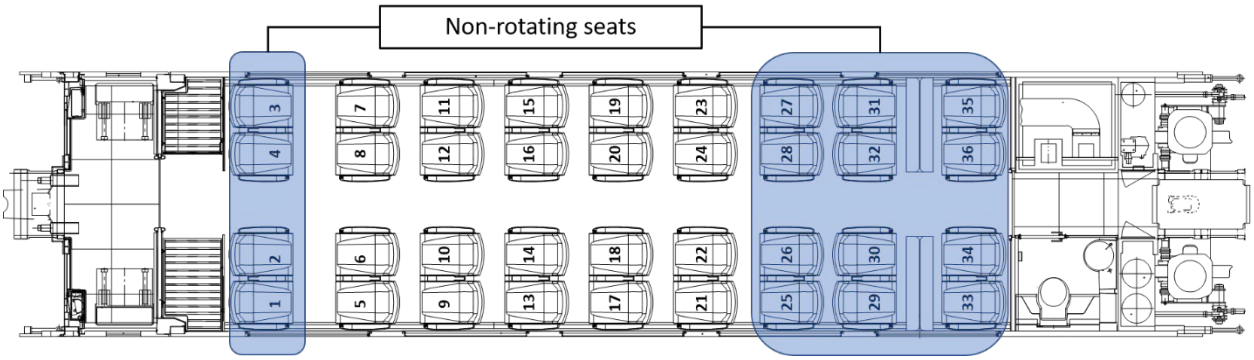
Figure 30. Coach class seating layout showing rotating and nonrotating seats.

Some of the seats in the Talgo Series VI train are designed to rotate which can decrease the effectiveness of compartmentalization when the seats rotate during an accident. (See figure 30.) In this derailment, investigators observed several seats that had rotated with passengers causing injury. To understand the nature of the injuries and why the seat rotation occurred, NTSB investigators examined the design.

Postaccident interviews revealed that several passengers in AMTK 7423 (9) were injured when three rows of seats started to rotate. One passenger was struck in the head with enough force to shatter the window. The seat corner of seat 2, which is not designed to rotate, contacted the rear bulkhead of the railcar, shattering the glass partition, directly behind the seat. A postaccident
